COMMISSION INTERNATIONALE
DES GRANDS BARRAGES

VINGT TROISIEME CONGRES
DES GRANDS BARRAGES
Stavanger, 2015

INCIDENTS AT GATED SPILLWAYS IN SOUTHERN AFRICA (*)

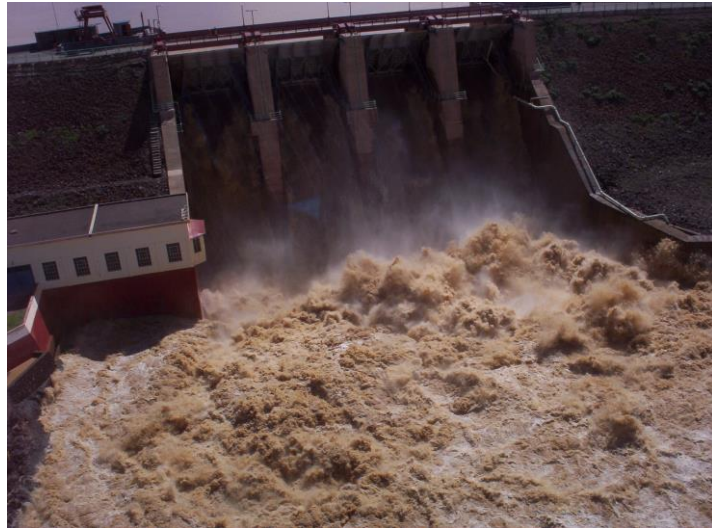
Fig. 1

An extreme flood event took place from 24 to 26 February 2006 (see Figures 1 and 2 for a view of the spillway and a graphical presentation of the flows and water levels versus time respectively) [1]. Late during the night of 25 February 2006 the national power supply line failed. When trying to use the backup generator it also failed. Fortunately there was a third option (a small mobile generator that should be operated at each individual gate) as well as well-trained onsite personnel as an increase in the flood release was required during this period with two of the power sources not available.

Subsequent analysis has clearly indicated that the dam may have failed or suffered serious damage if the power failure occurred earlier (for example early morning of 25 February 2006) and the third power option was not available. This case study clearly highlights the importance of sufficient redundancy of especially power sources (preferably 3 options) as well as properly trained and well informed operating personnel.

Aerial view of the spillway of Hardap Dam spillway during the 2006 flood event

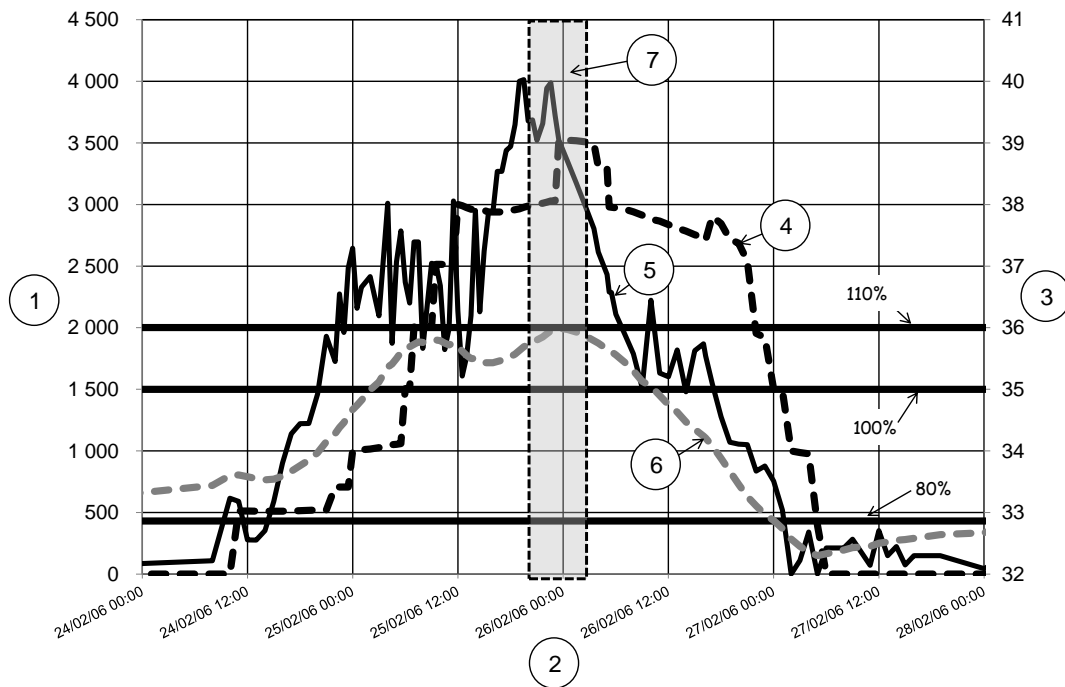
Fig. 2

Hardap Dam: 2006 flood event flows and water levels versus time

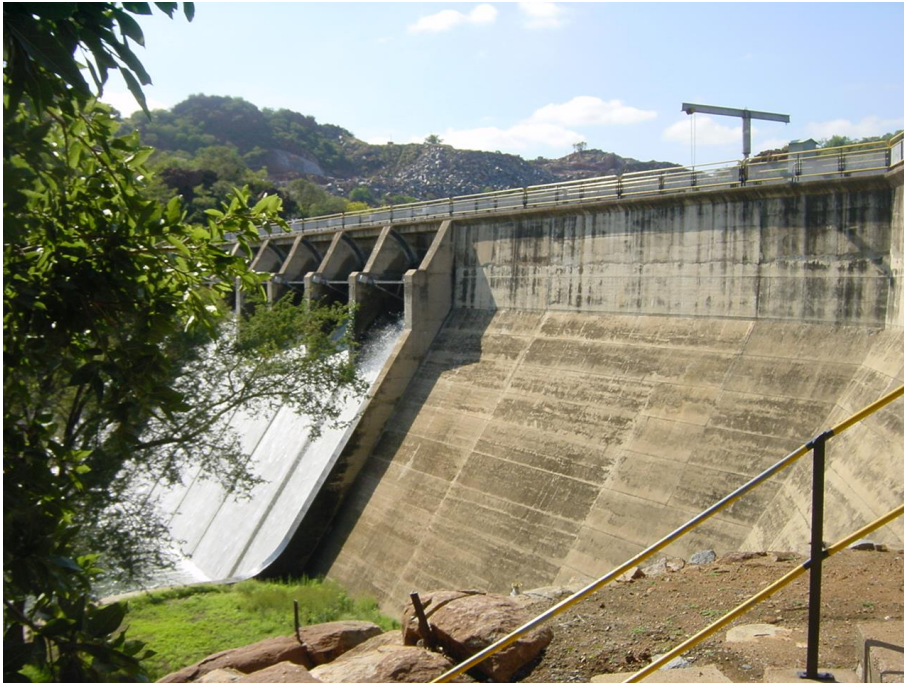
Fig. 3

The control system for the radial gates only had two power sources – the national power grid and a small mobile generator (that should be operated at each individual gate). In addition, the dam operator was not stationed at the dam. He was based 30 km away at another dam with no water level warning system in place. During the inspection it was first observed that water was flowing over the radial gates. When attempting to open the radial gates to lower the water levels (as the radial gates were not designed for overtopping flow) it was discovered that not only was the power cable from the national grid was stolen, but also the backup generator had issues to be started as it was not regularly operated and in addition 5 of the 12 gates' cables were completely corroded.

This case study clearly highlights that the 2004 situation could be described as a failure waiting to happen. None of the requirements for the proper operation of a gated spillway system were complied with as there was not sufficient redundancy of the power sources, the operator was not stationed at the dam, the

gates were not tested before each flood season and the maintenance were not up to standard.

Gated spillway of Bospoort Dam during the 2004 dam safety evaluation

From the results of the dam safety evaluation [2] presented in Figure 4, it was clearly evident that the risk level encountered during the 2004 inspection was totally unacceptable with probabilities of failure of the dam of between 1×10^{-1} and 1×10^{-2} . It was also evident that risk level of the dam was still unacceptable even with the gated spillway fully functional (with probabilities of failure of the dam of between 1×10^{-2} and 1×10^{-3}). Subsequently the dam was rehabilitated by replacing the gated spillway with an uncontrolled labyrinth spillway and providing an additional uncontrolled labyrinth spillway on the right bank and raising the earthfill embankments. As a result the risk level of the dam is now acceptable.

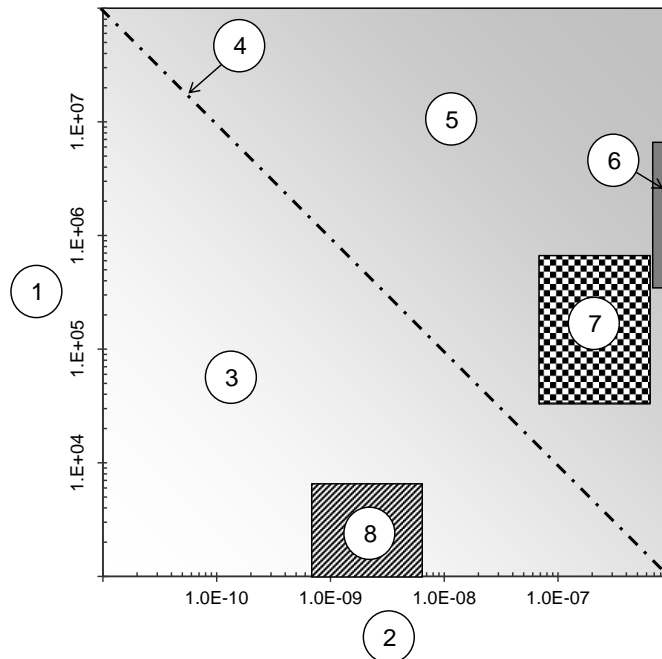
Fig. 4
Risk levels of Bospoort Dam

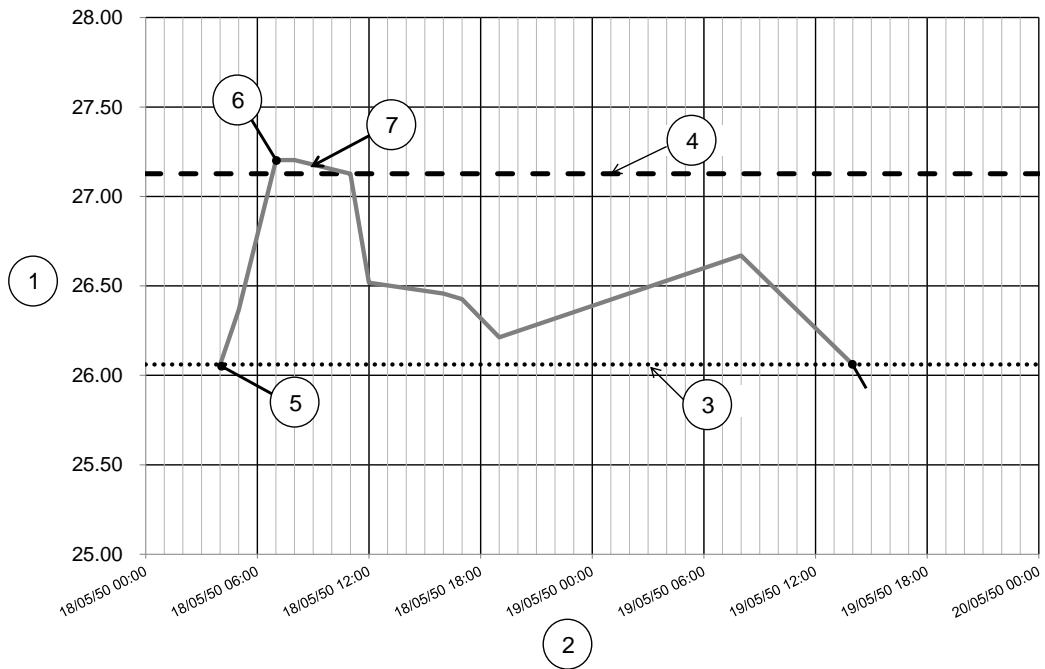
An extreme flood event took place from 18 to 19 May 1950 (see Figure 5 for a graphical presentation of the water level versus time) [4]. Very early in the morning of 18 May 1950 the operator was informed that a flood was on its way. Around 4 am on 18 May 1950 the first gate was opened and an effort was made to open as many gates as possible. By 7 am a total of 20 gates were fully open. The water, however, started overtopping the non-overspill crest as the operator was not able to open enough of the gates. As soon as the overtopping started the operator feared for his own safety and abandoned the operation of the gates. As a result overtopping of the non-overspill crest took place for a total of 4 hours. No

significant erosion damage of the downstream foundation was fortunately evident.

This case study clearly highlights the importance of making sure that the opening speed of the gate system is sufficient for the site conditions. Also the importance of redundancy of the power sources (in this case only one option was available) as well as proper regular maintenance (after more than 50 years of no maintenance the gates were no longer operable).

Fig. 5
Lake Arthur Dam: 1950 flood event water levels versus time
