Dam Safety in a Water Resource Environment

Dam Safety Regulation in South Africa: 32 years down the line

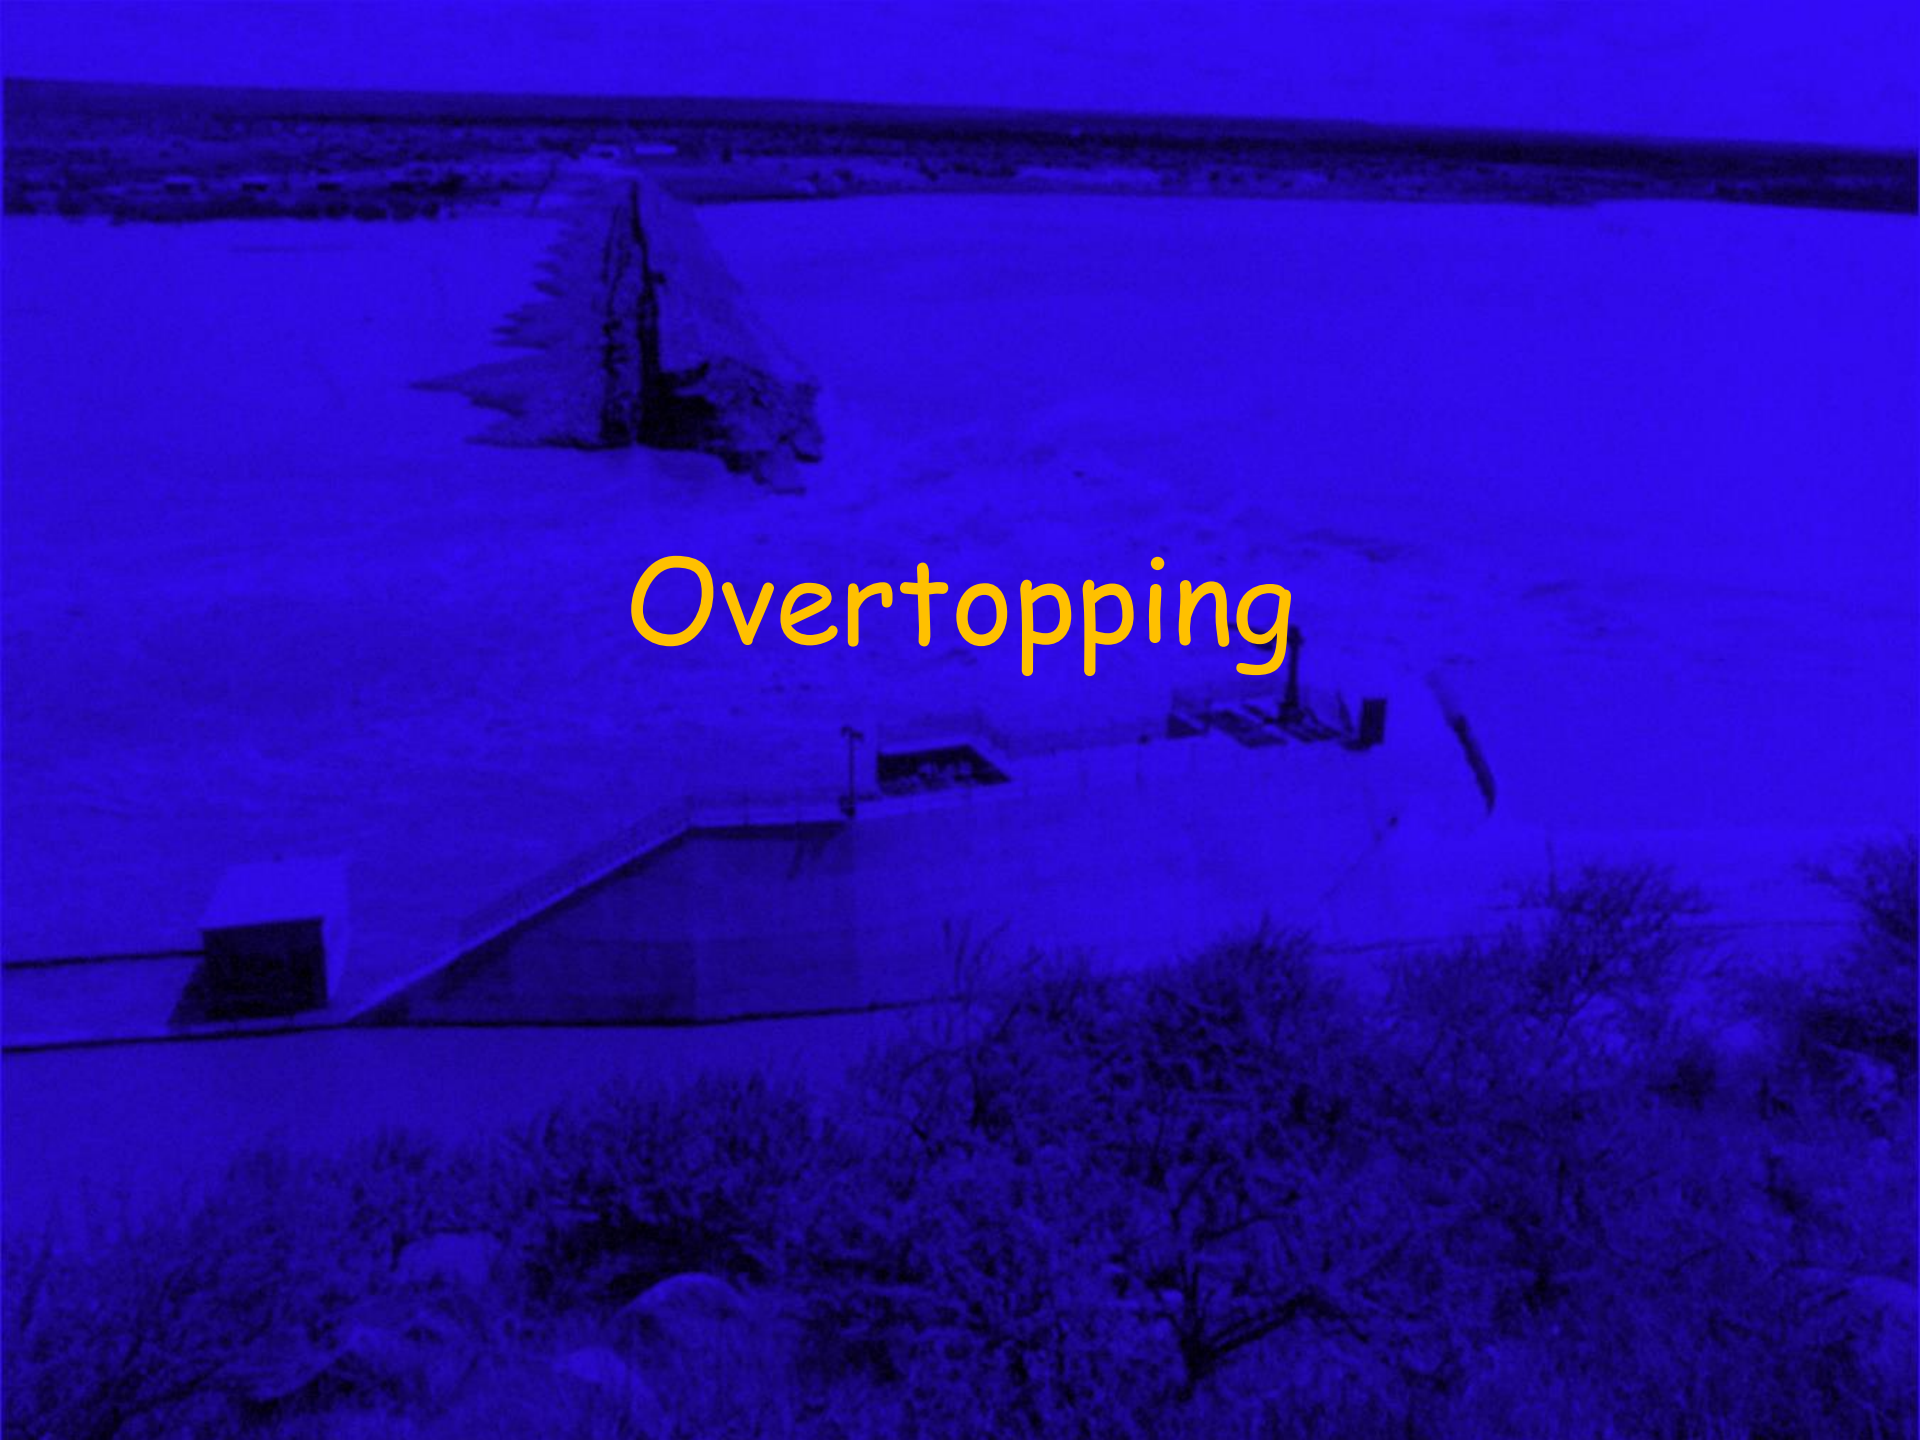
A photograph showing a dam structure with a significant breach in its spillway. The water level is high, and the structure appears to be failing. The text is overlaid on the image.

Overtopping failure = spillway
capacity is NOT sufficient

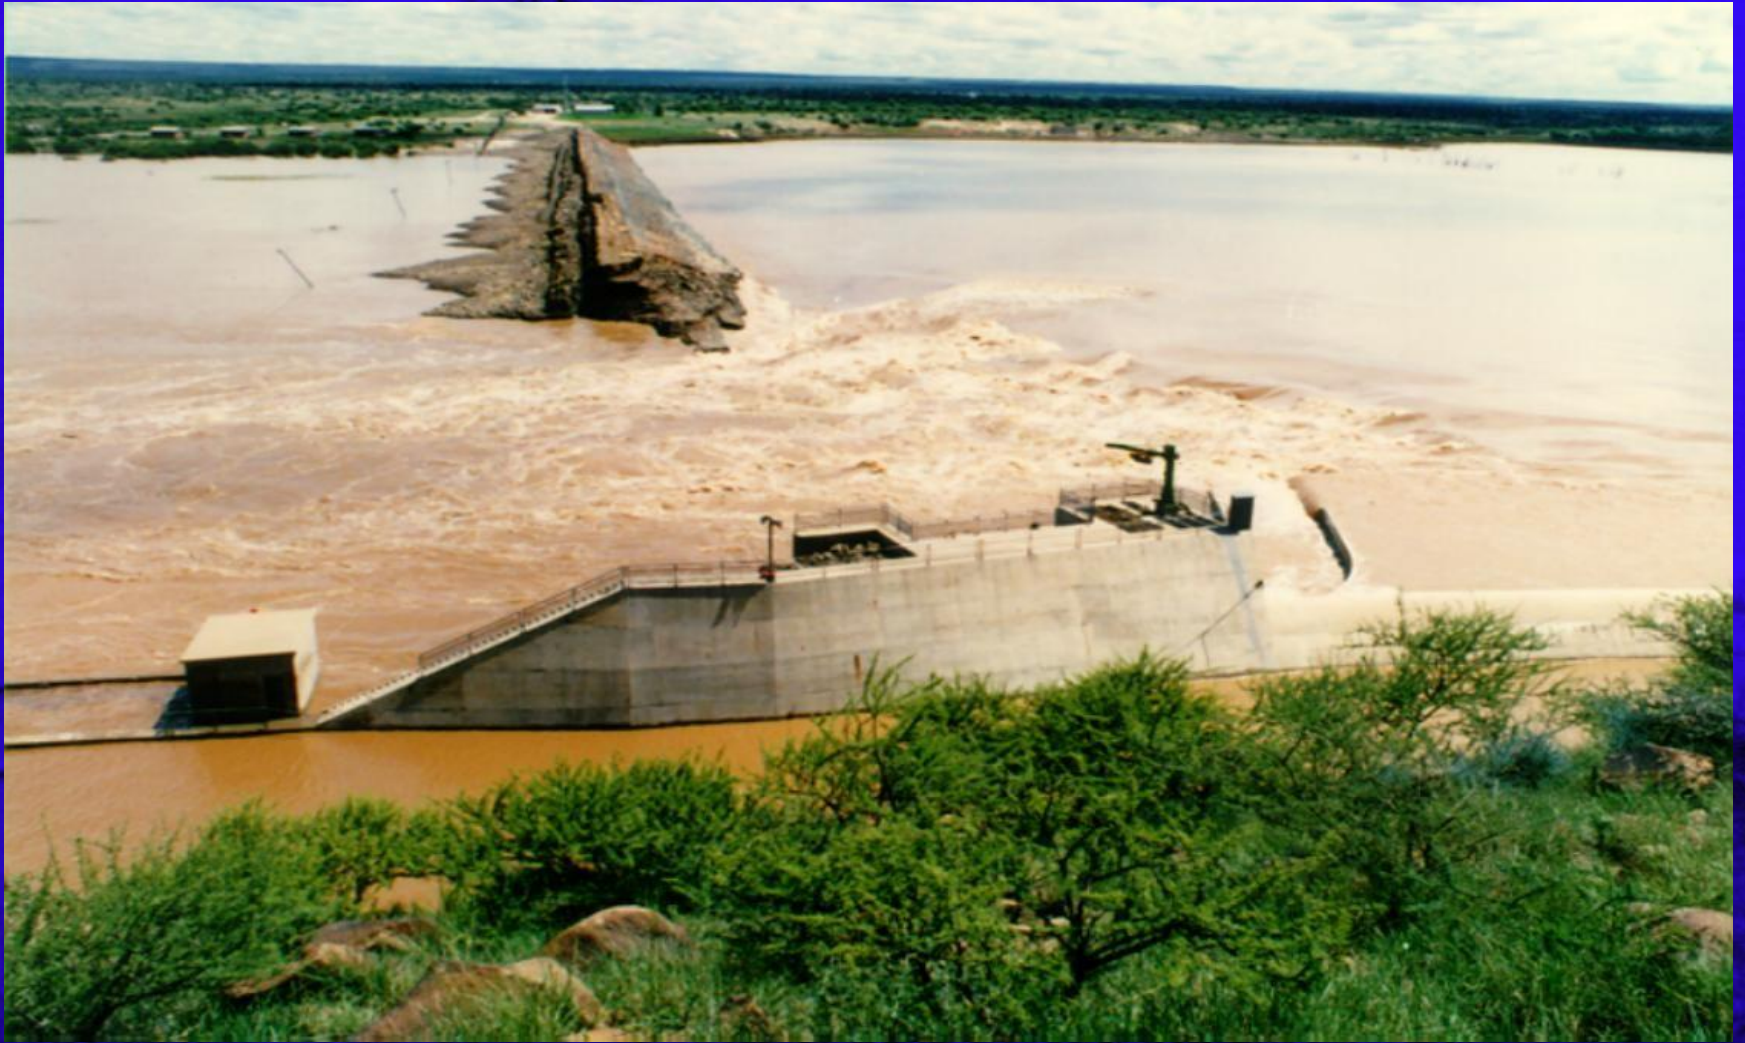
Spitskop Dam, South Africa 1988

Construction issues

- Make sure dam is built to designed levels
- Spillway built to the correct dimensions
- **PROPER As-Built drawings**

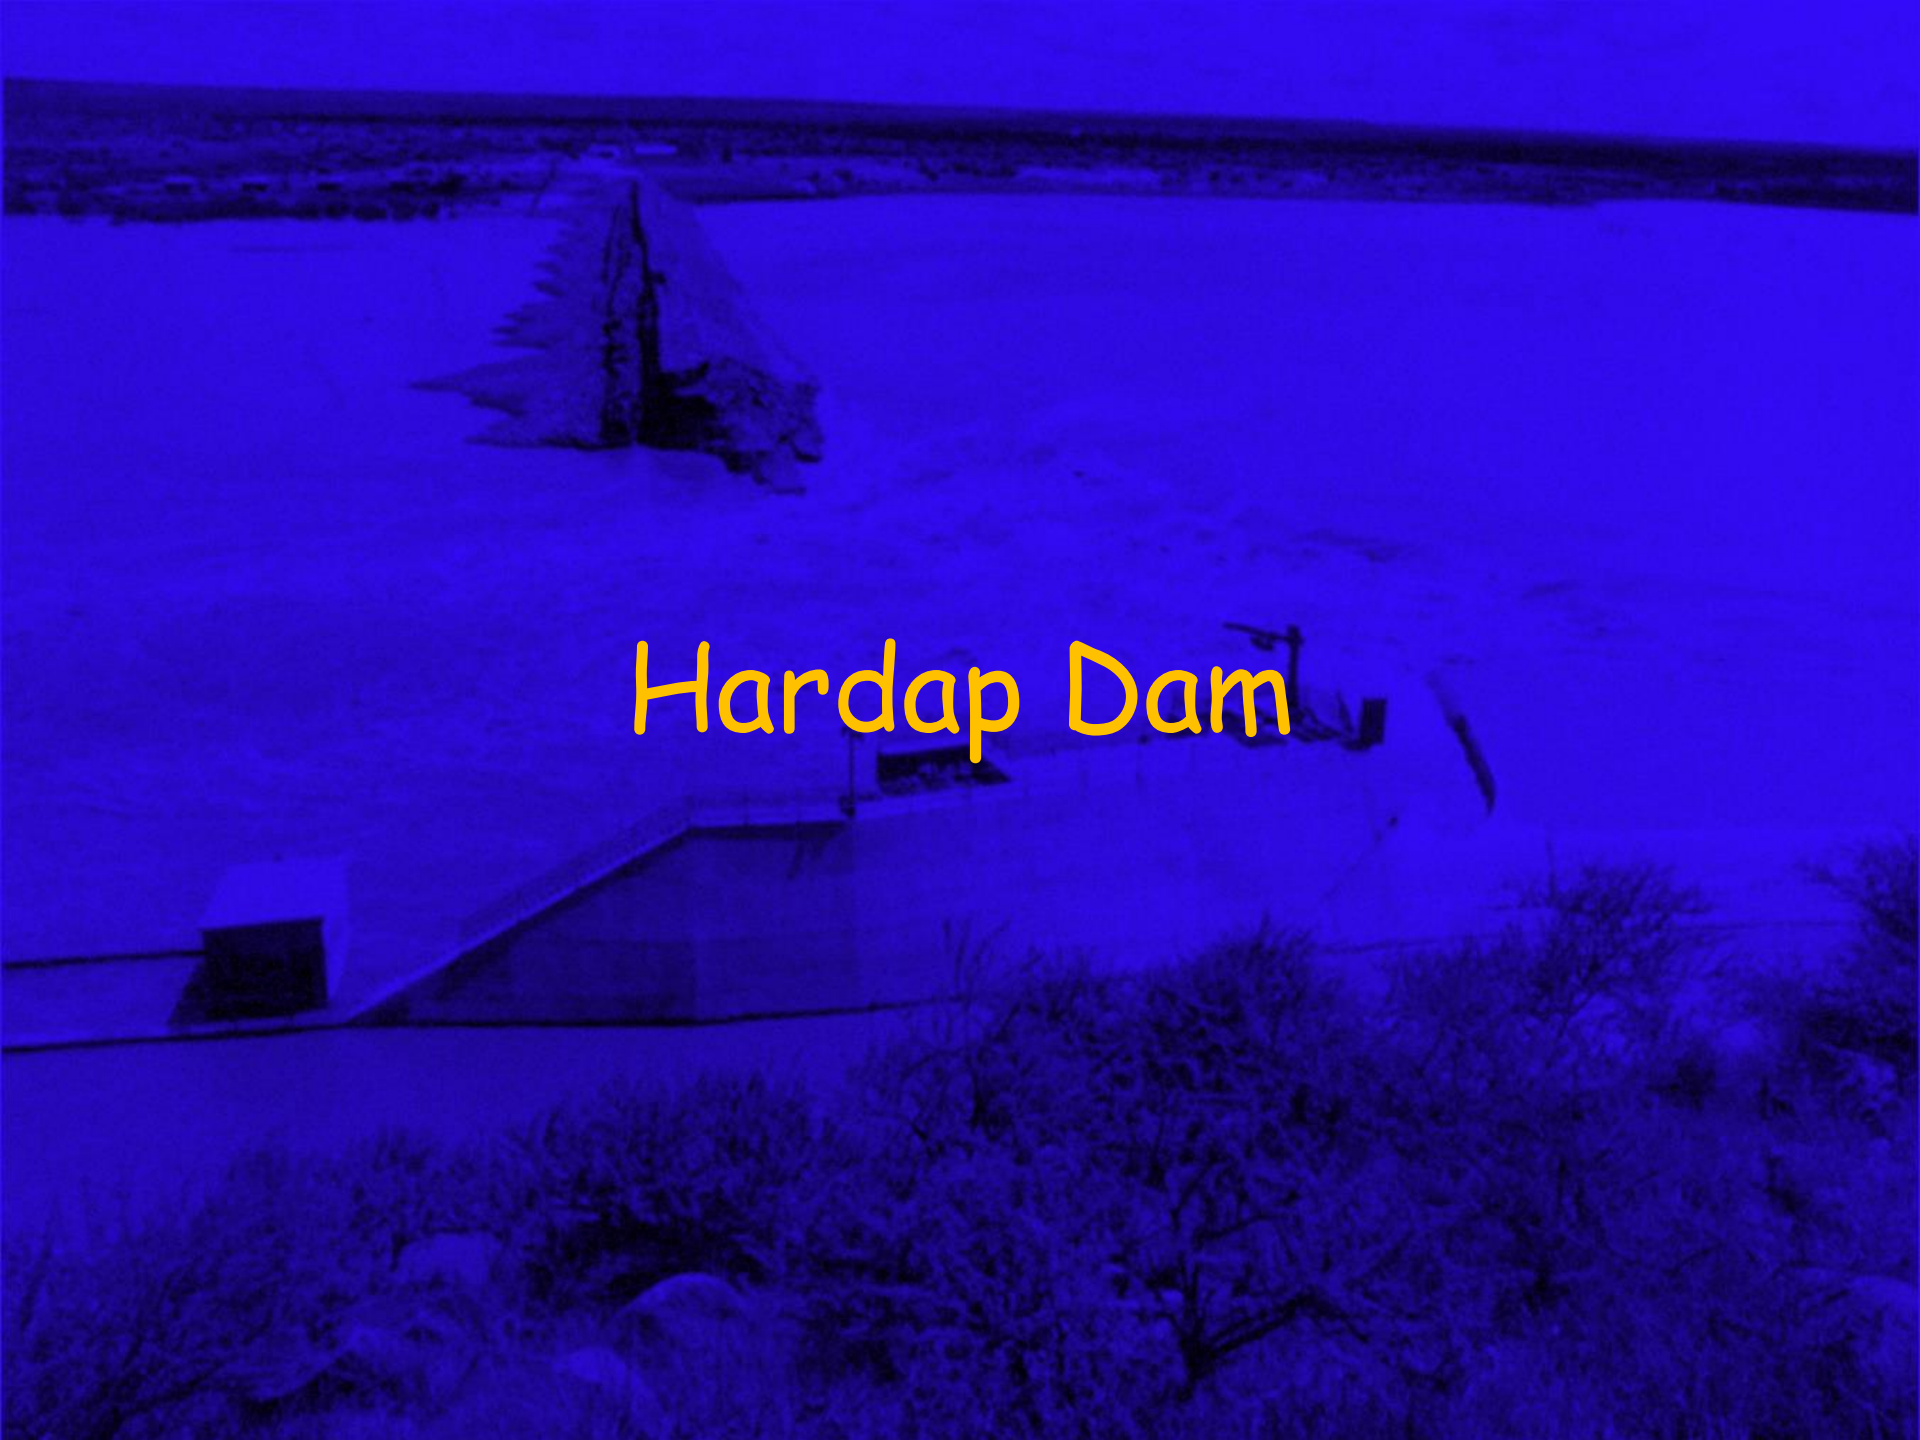
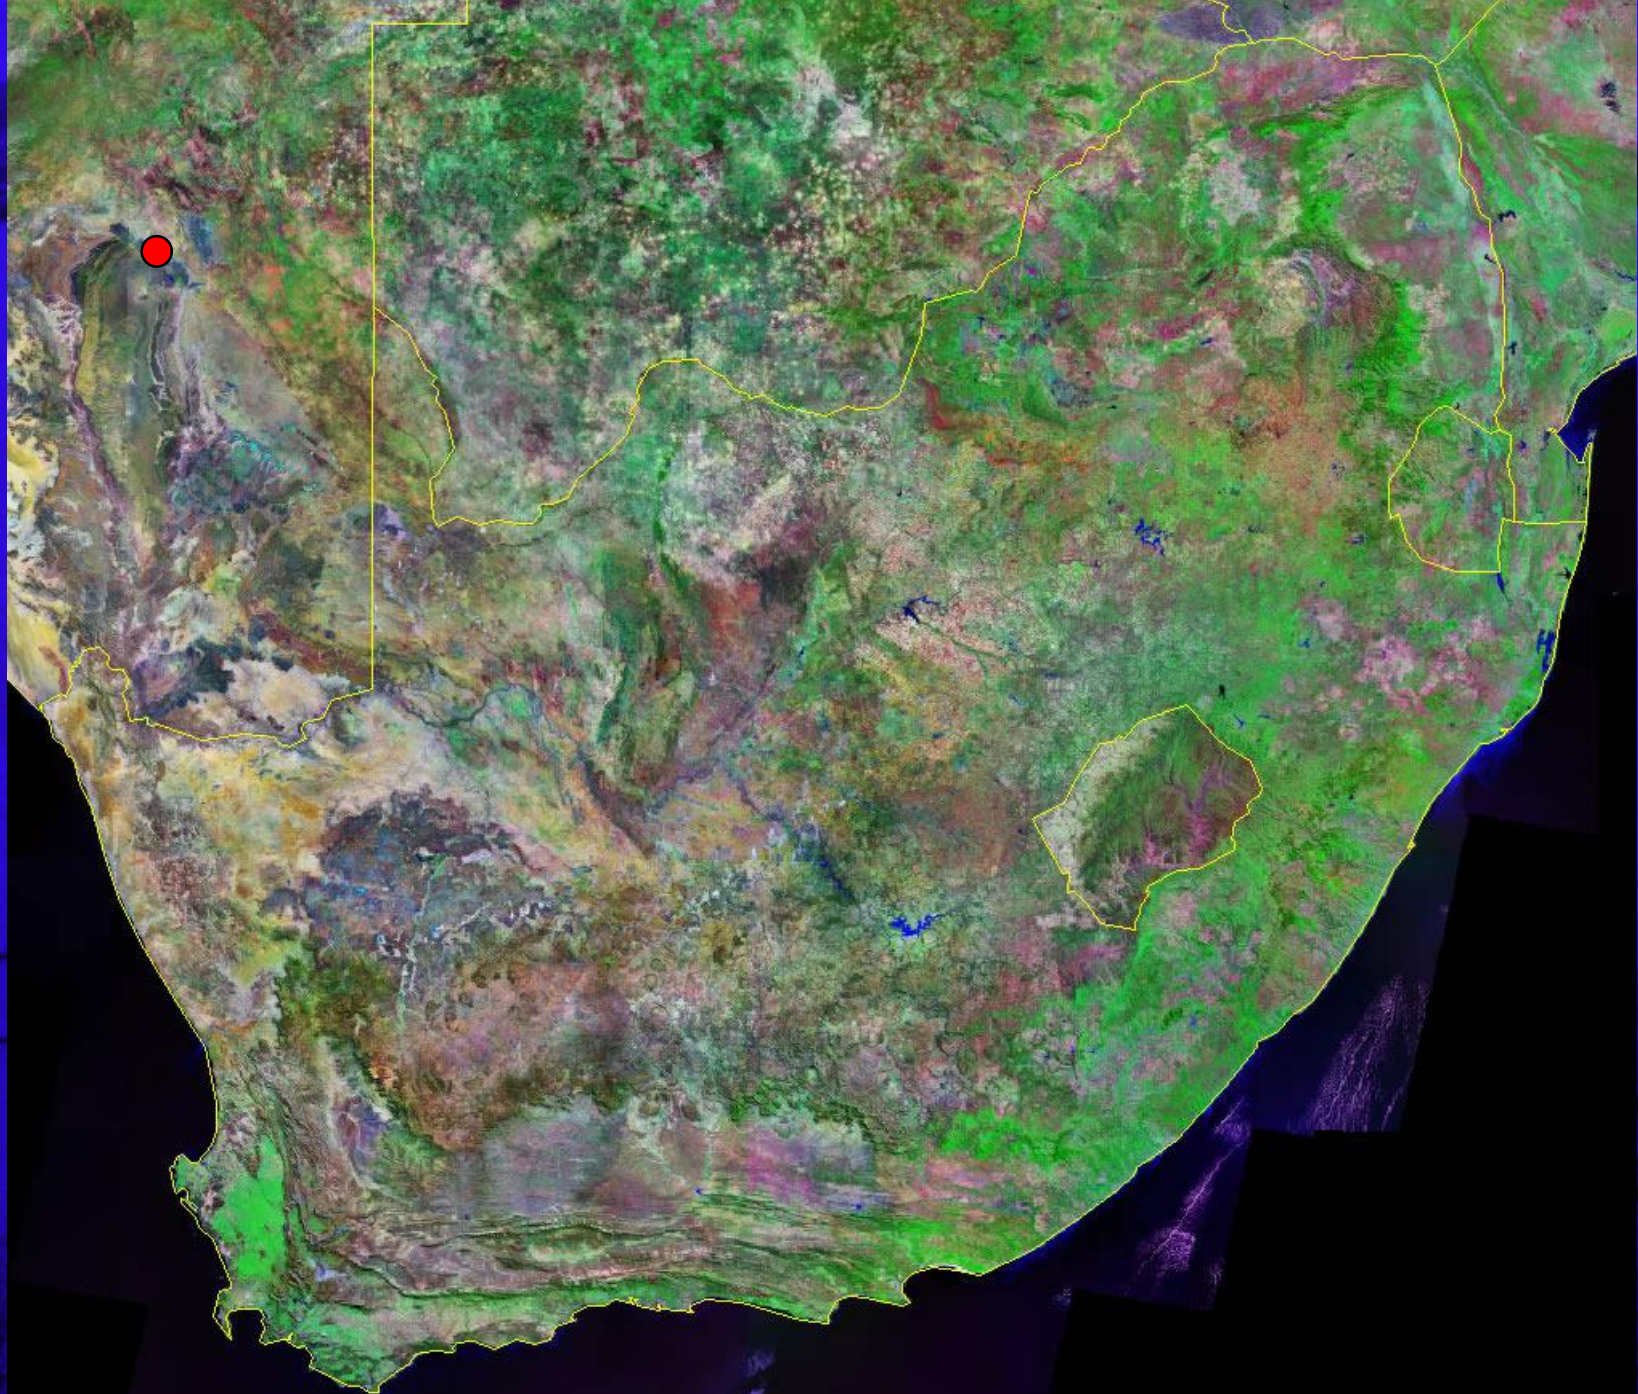
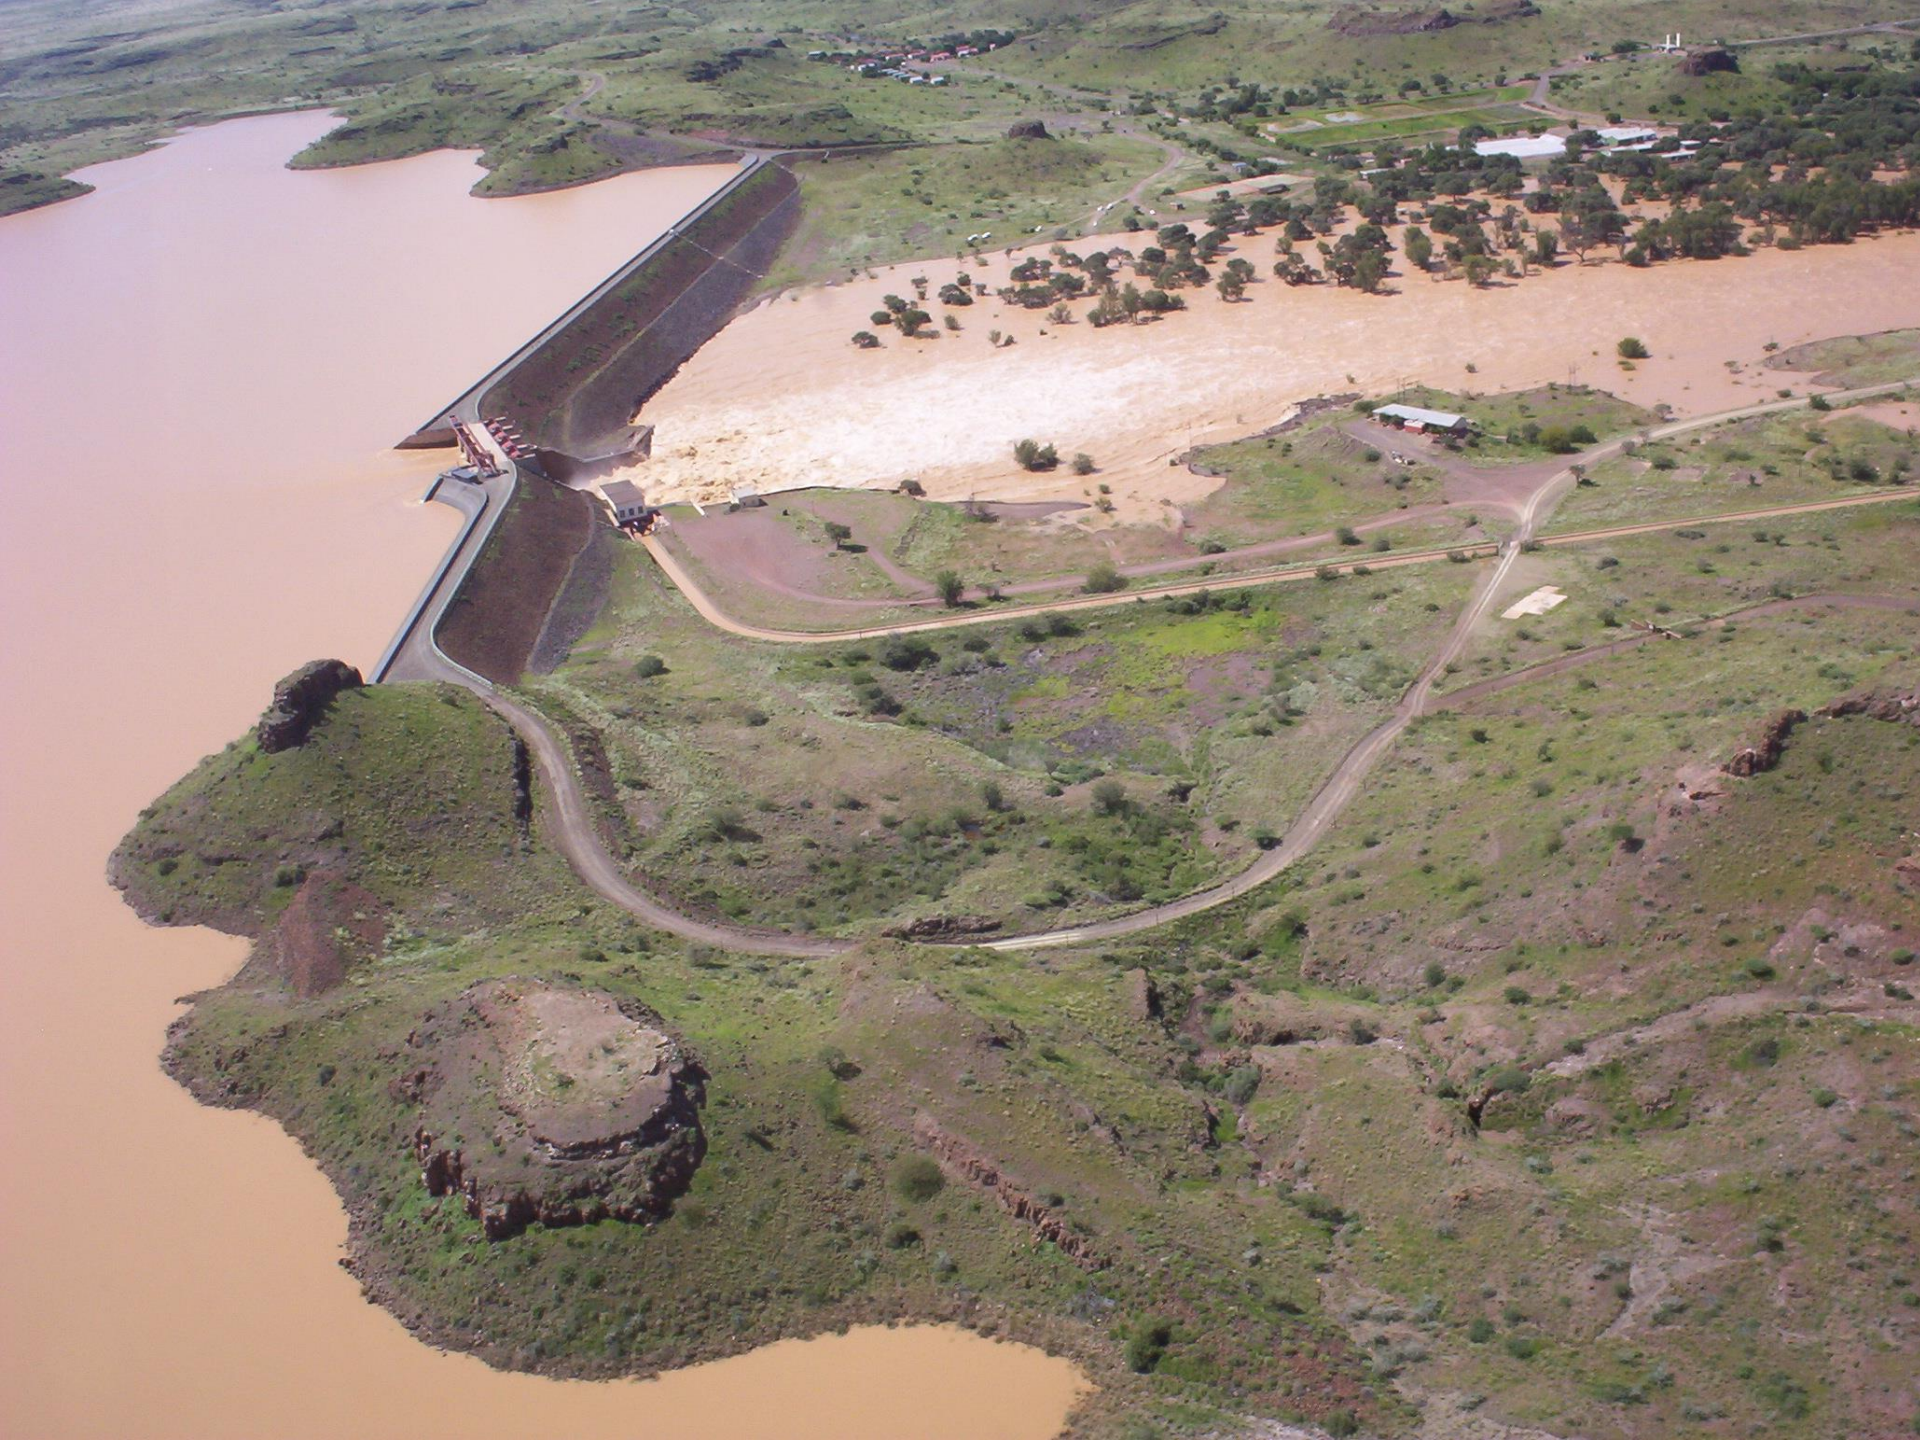
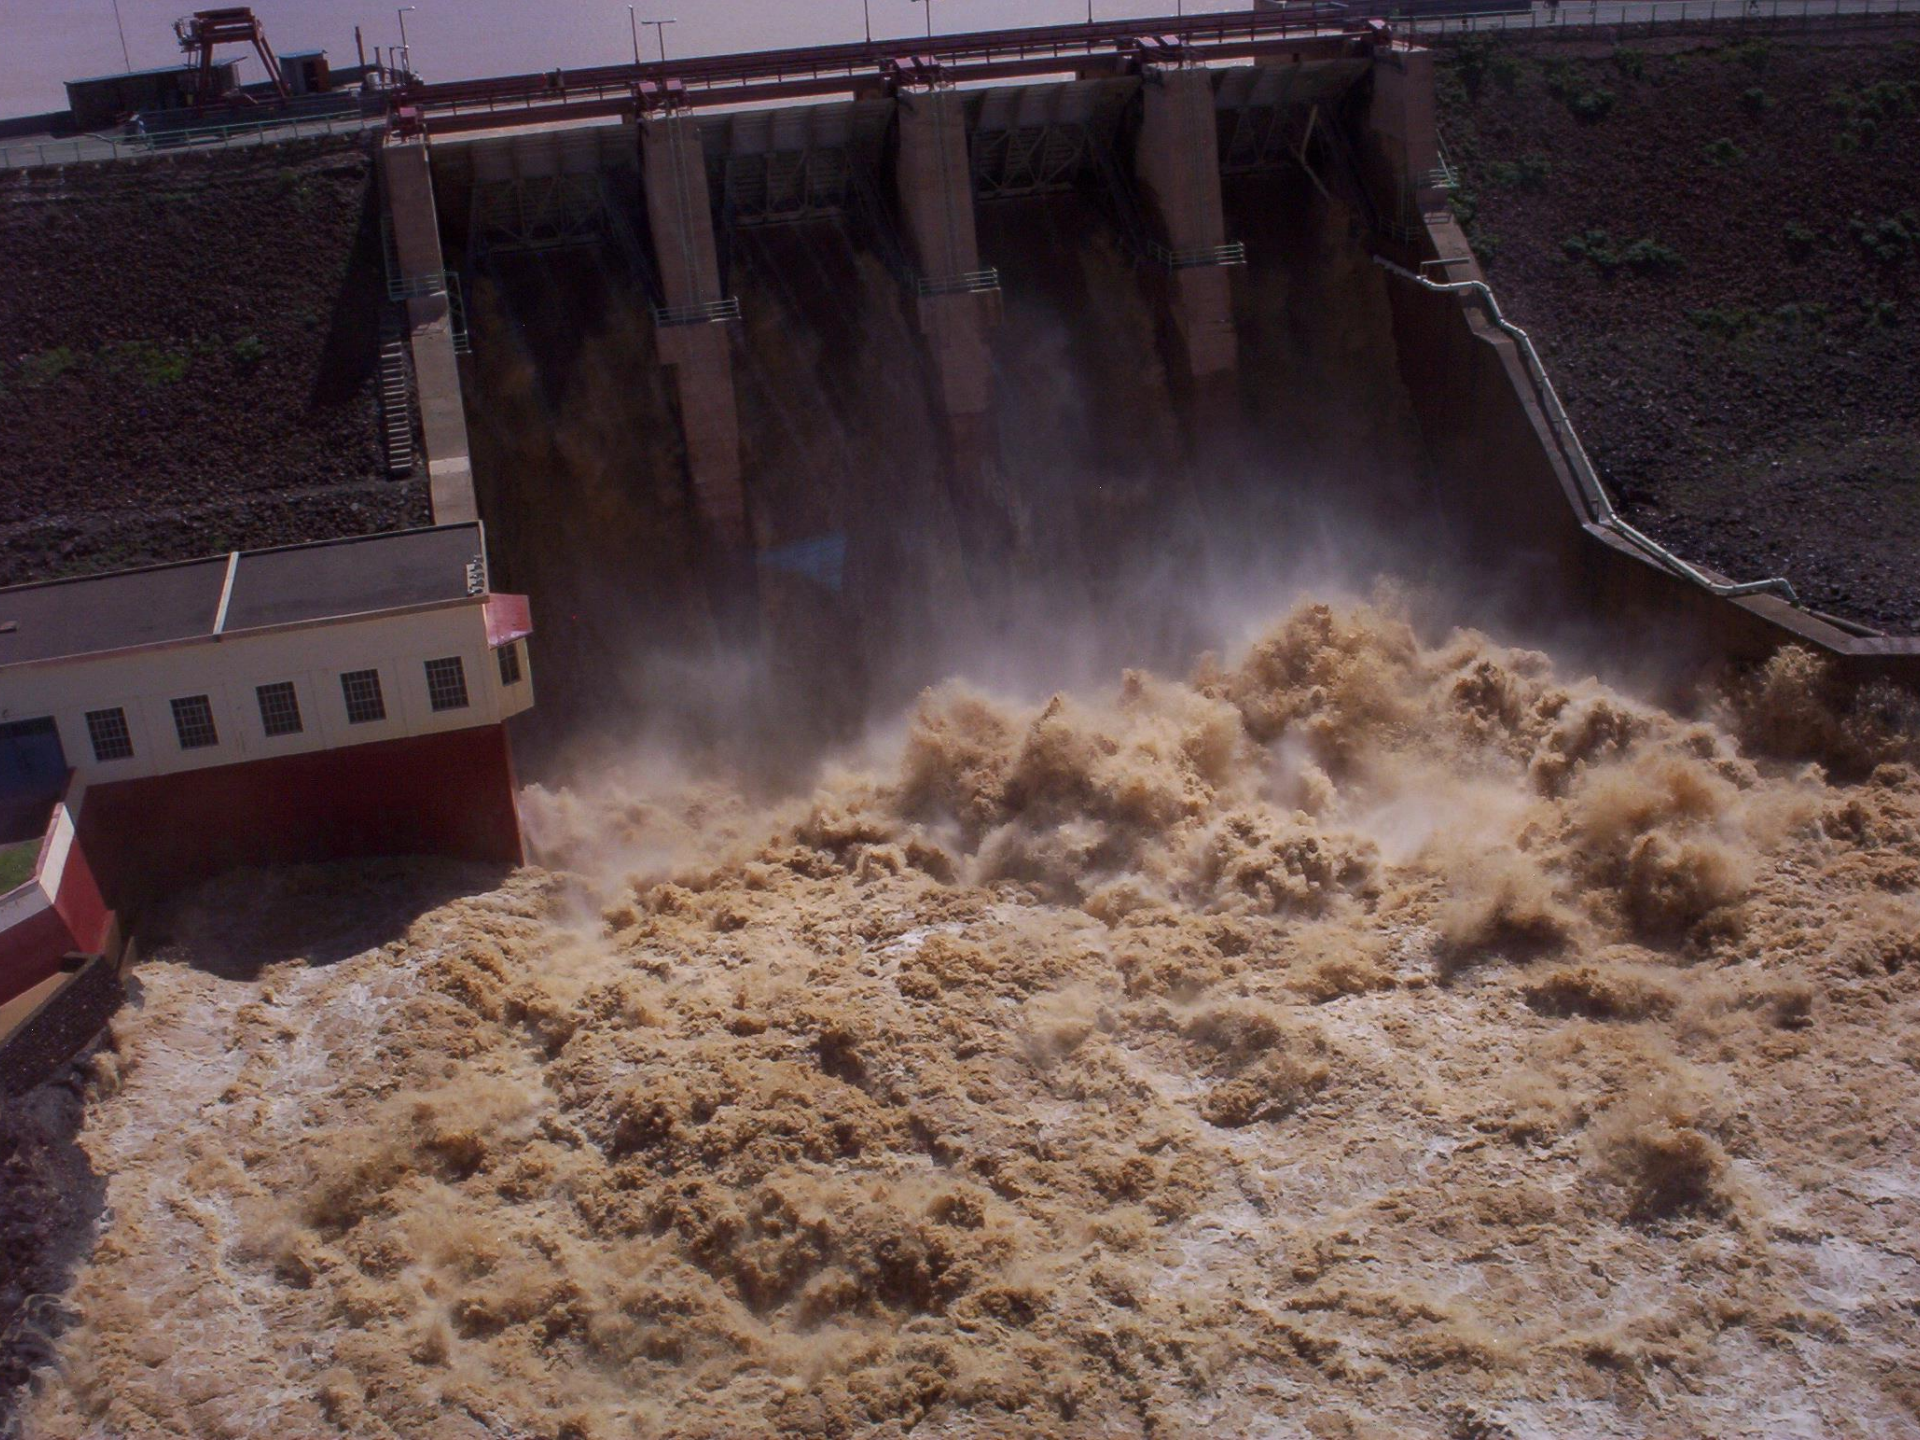
Hardap Dam

- Asphalt concrete faced rockfill embankments with centrally located controlled ogee concrete gravity spillway: 35.9 m high
- Completed in 1963
- 4 radial gates: 11.1 m high x 11.6 m wide

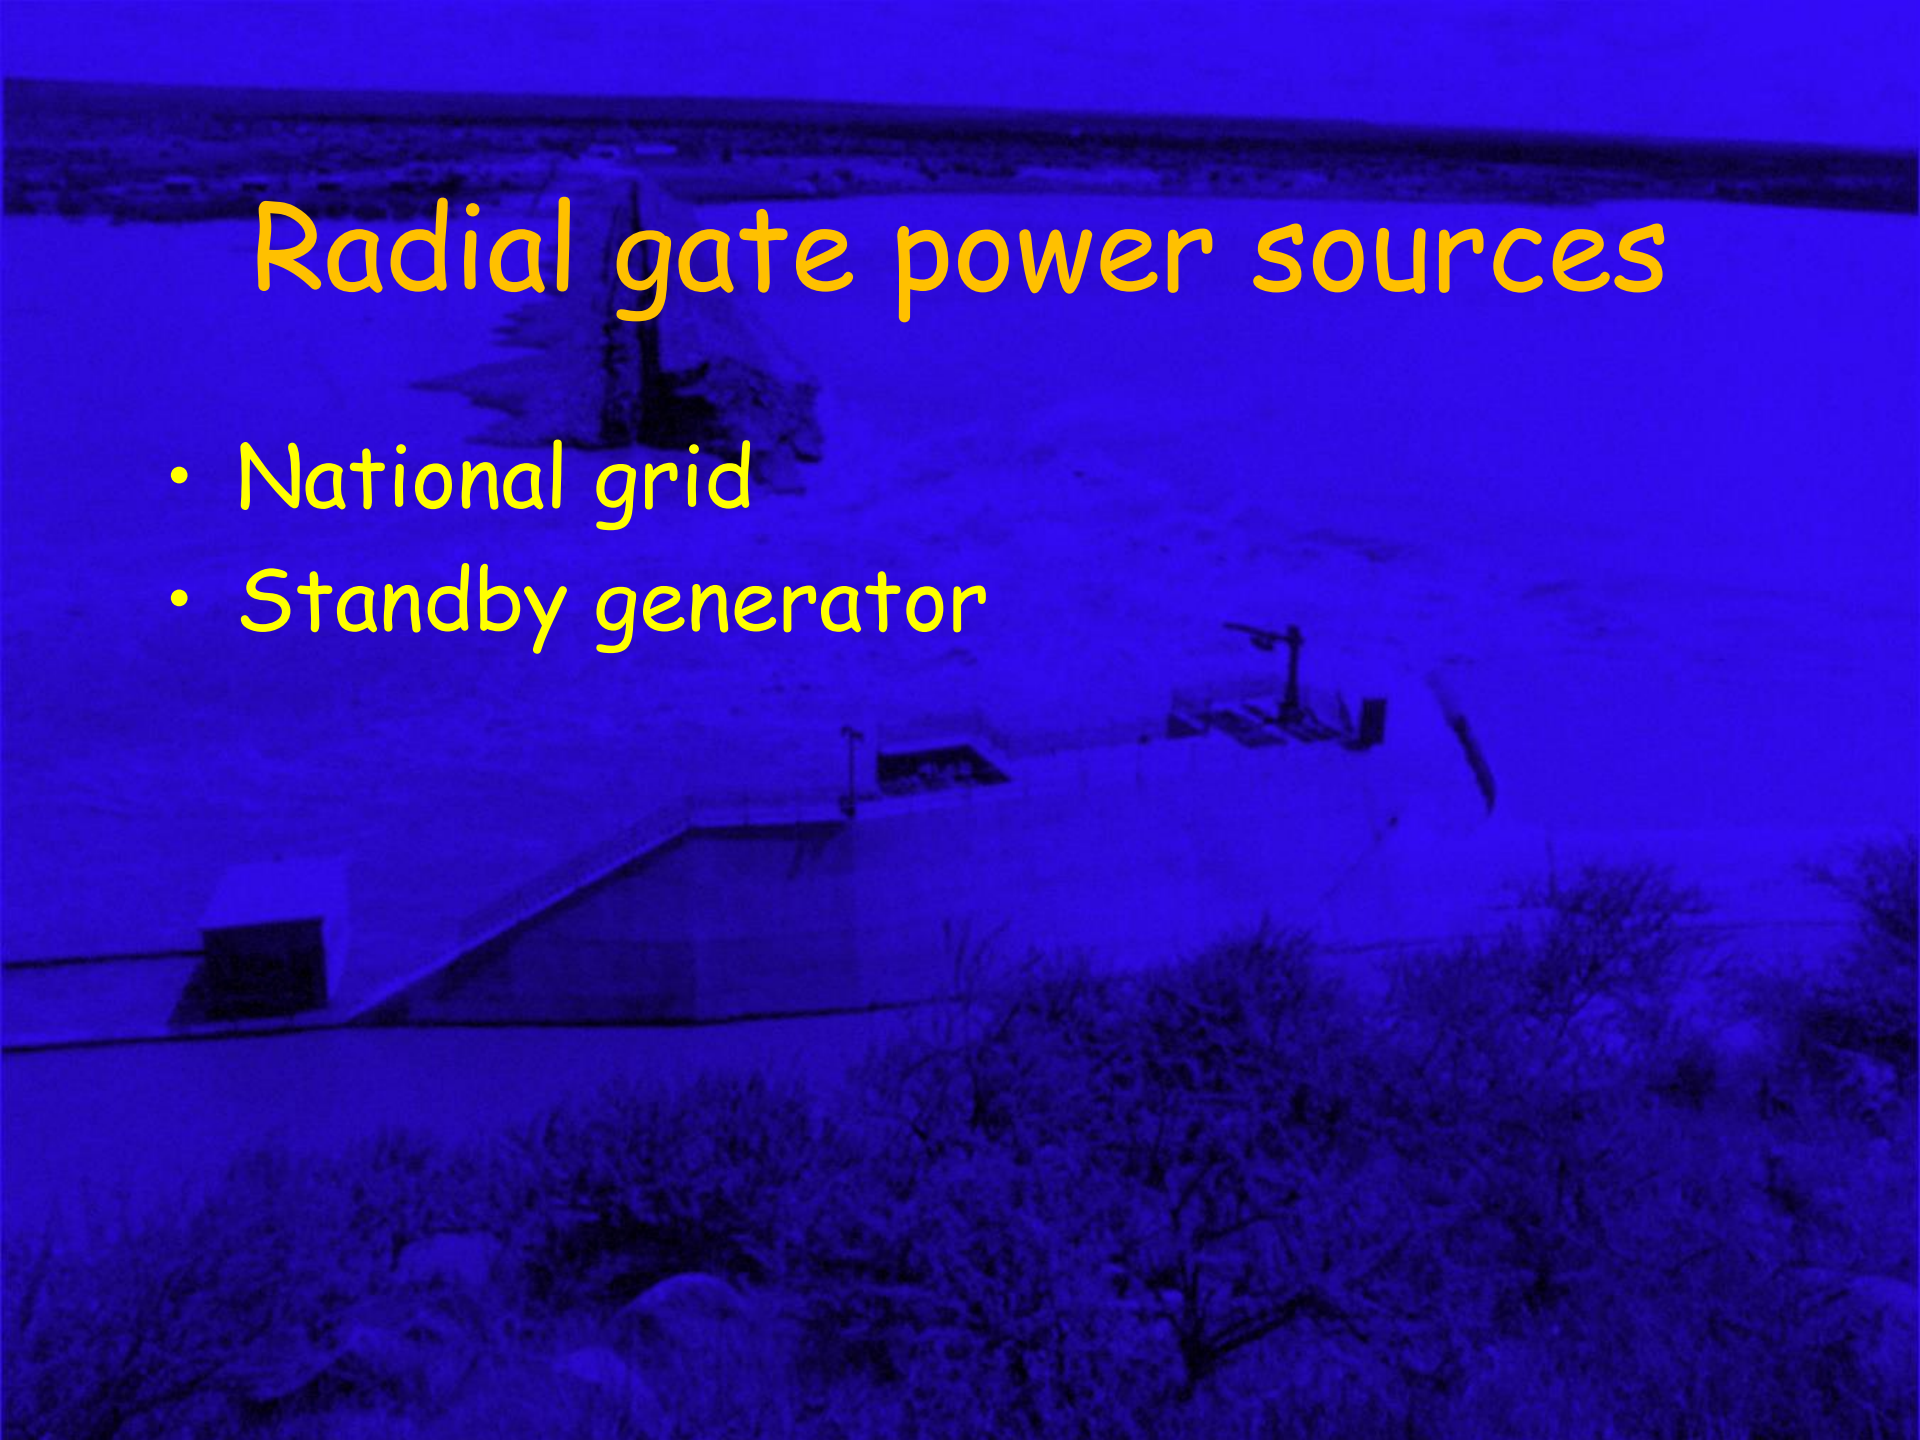
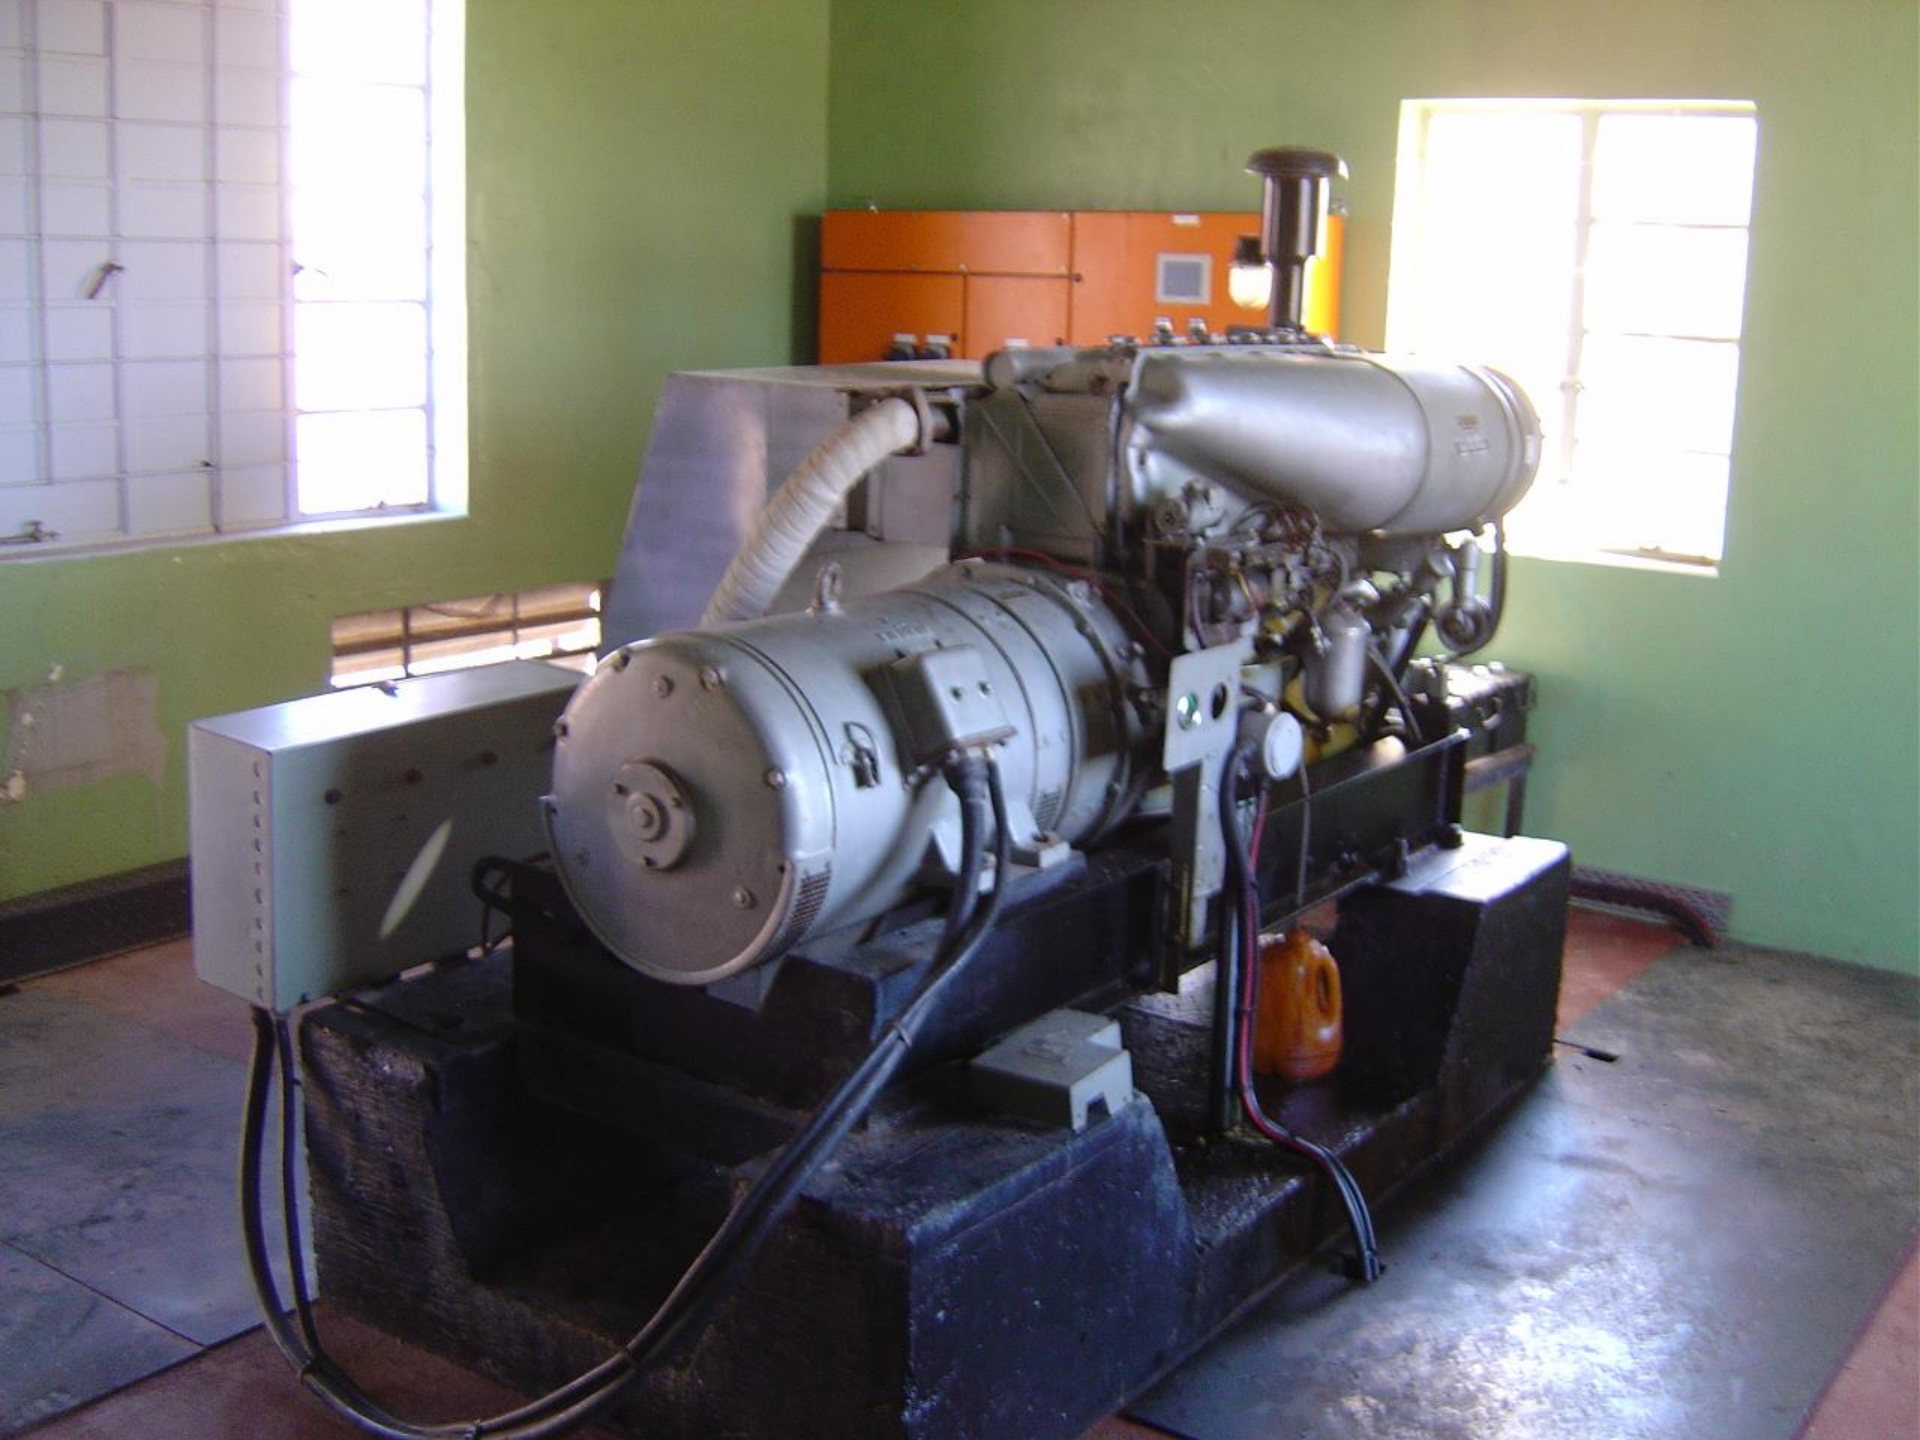
Radial gate power sources

- National grid
- Standby generator

- National grid
- Standby generator
- Small mobile generator operated at gates

- Operator not stationed @ dam (30 km away)
- Power cable stolen
- Backup generator not functioning
- 5 out of 12 gates' cables completely corroded
- Water spilling over gates
