Dam Safety in a Water Resource Environment

Dam Safety Regulation in South Africa: 32 years down the line

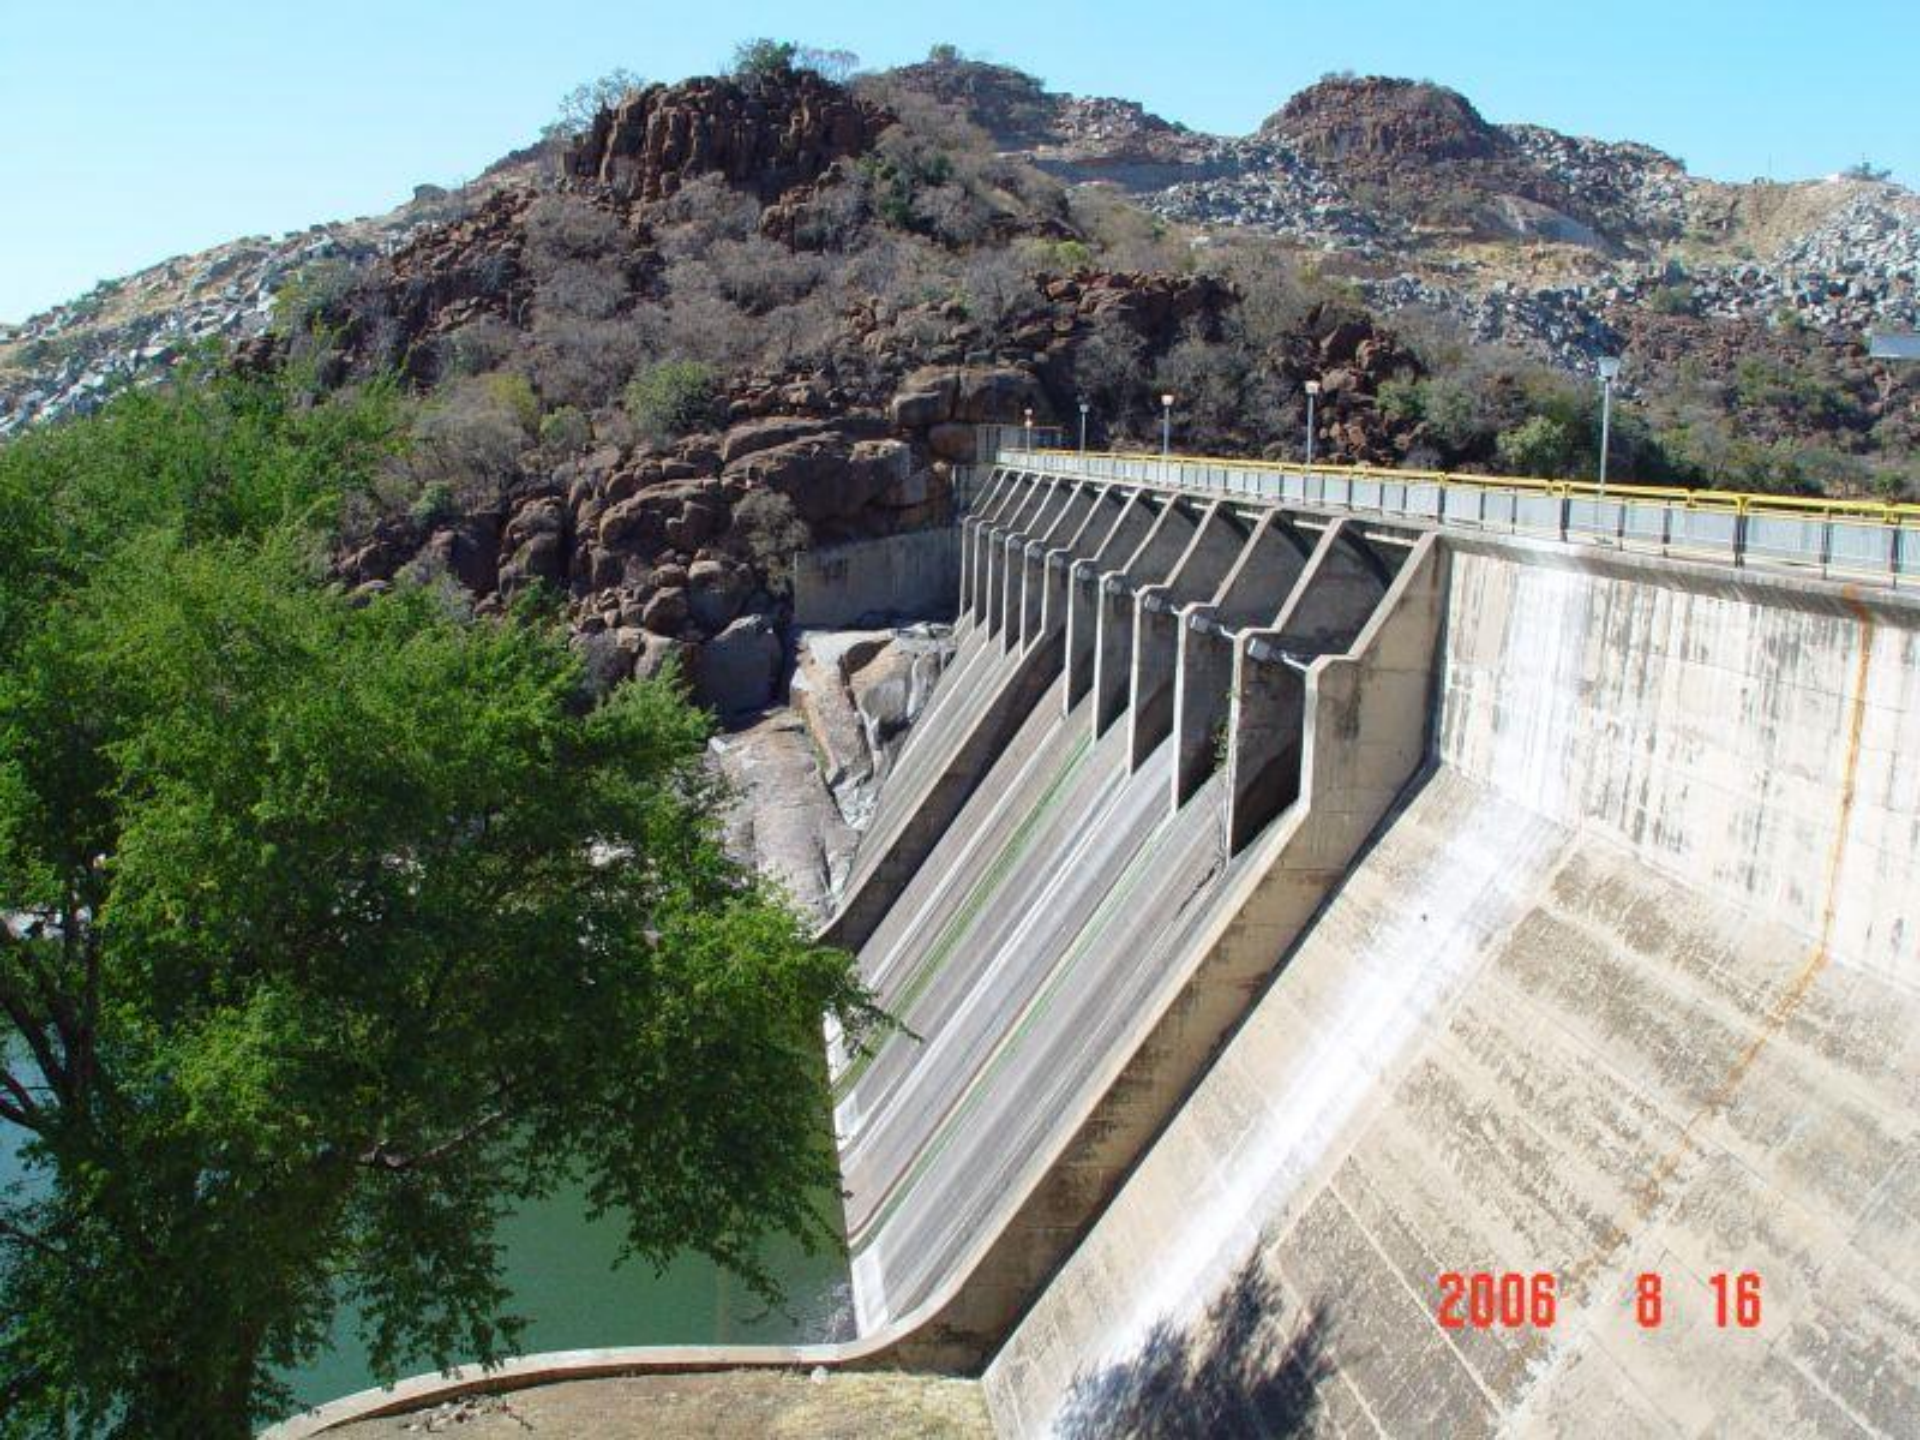
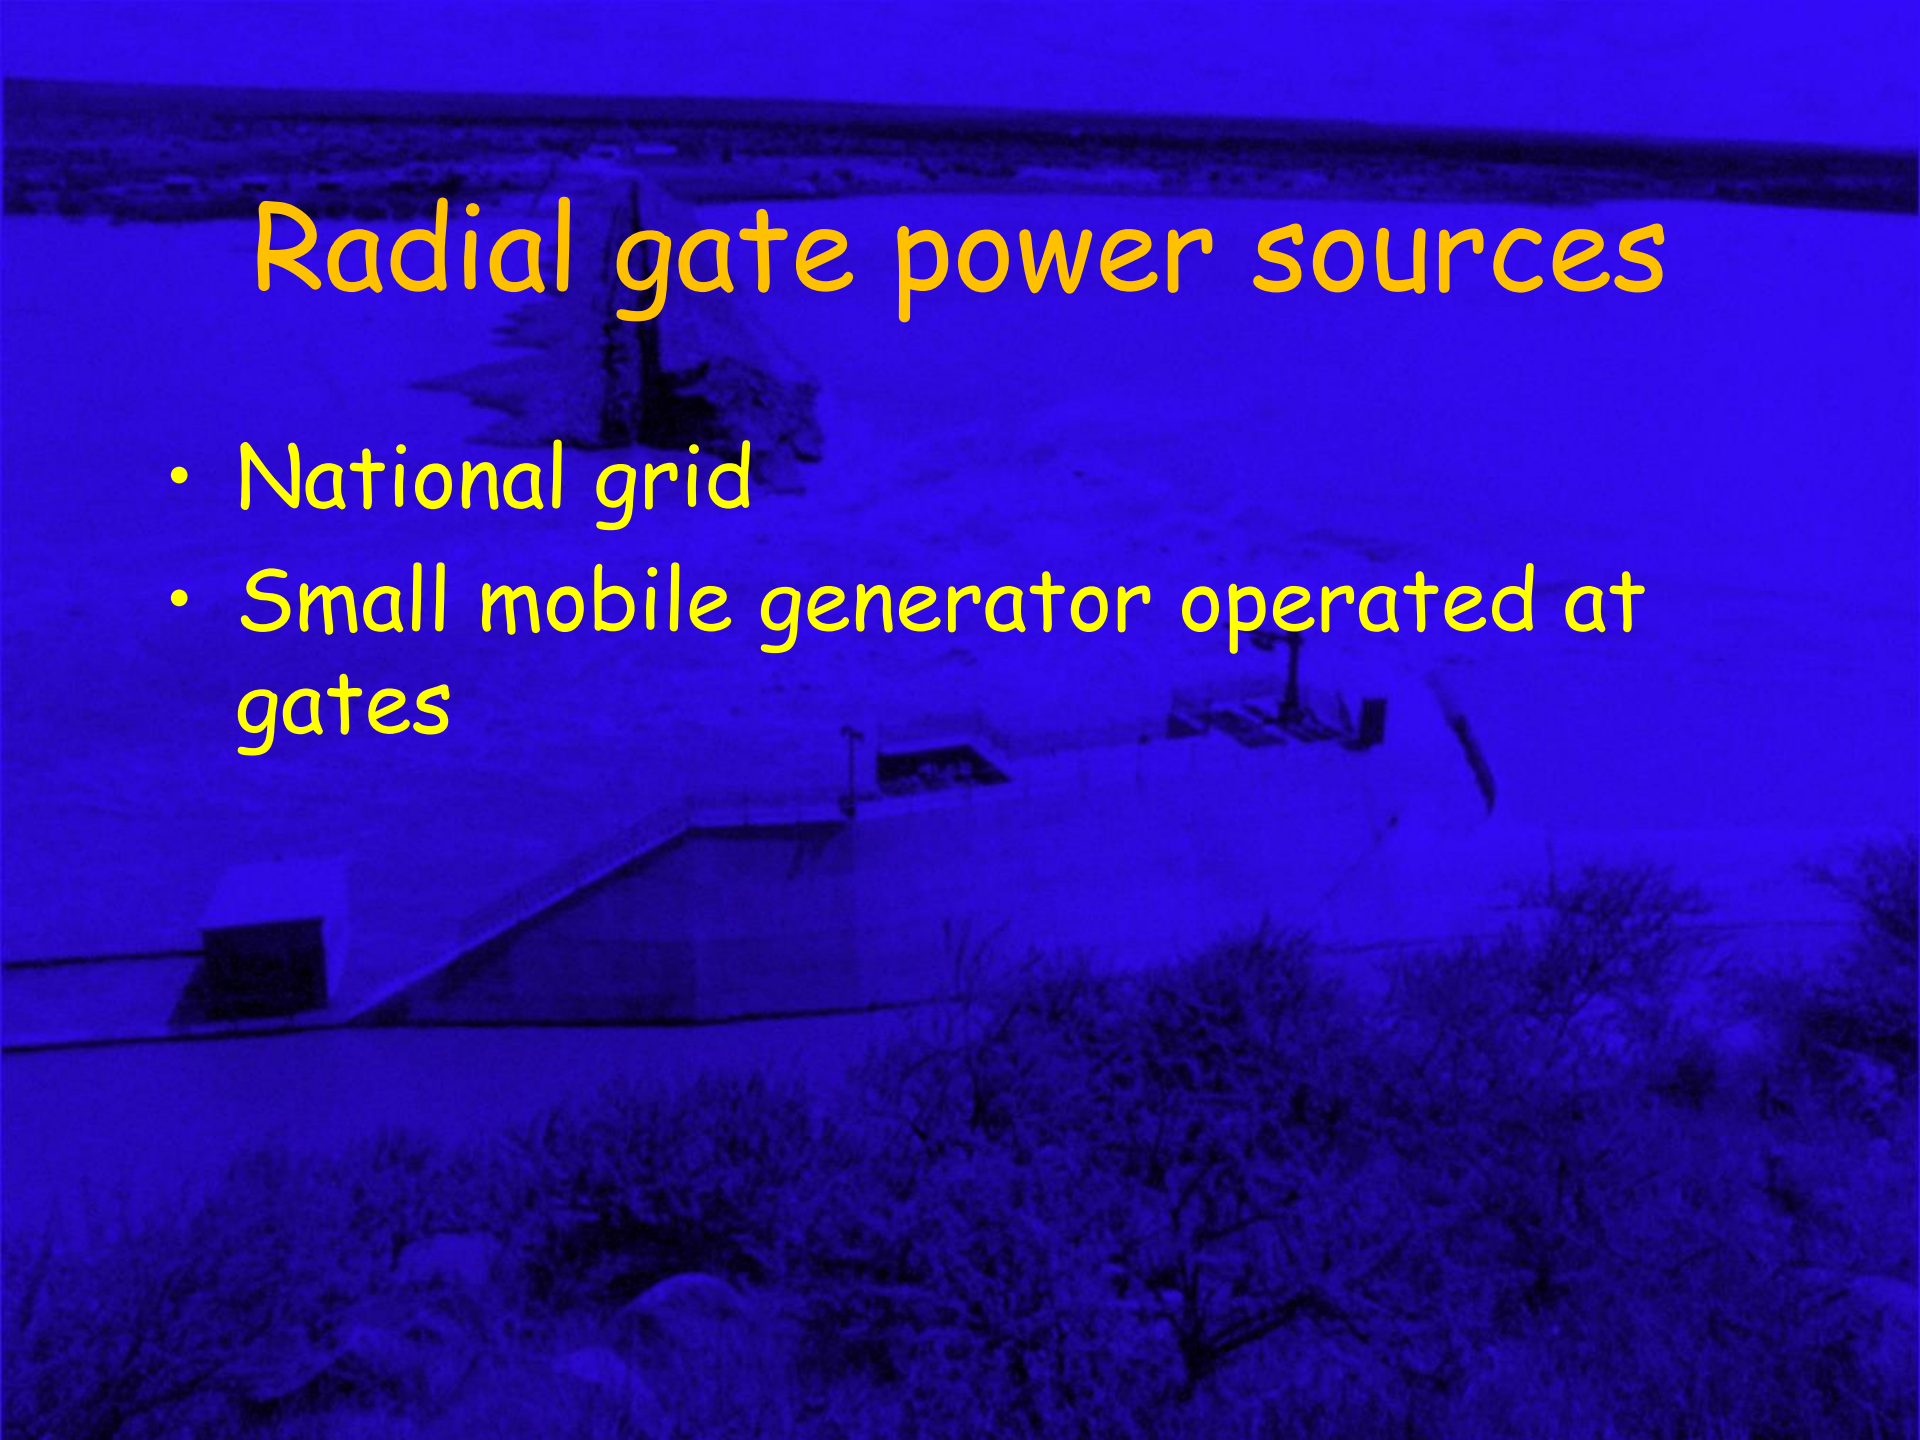
Bospoort Dam

Radial gate power sources

- National grid
- Small mobile generator operated at gates

- Operator not stationed @ dam (30 km away)
- Power cable stolen
- Backup generator not functioning
- 5 out of 12 gates' cables completely corroded
- Water spilling over gates

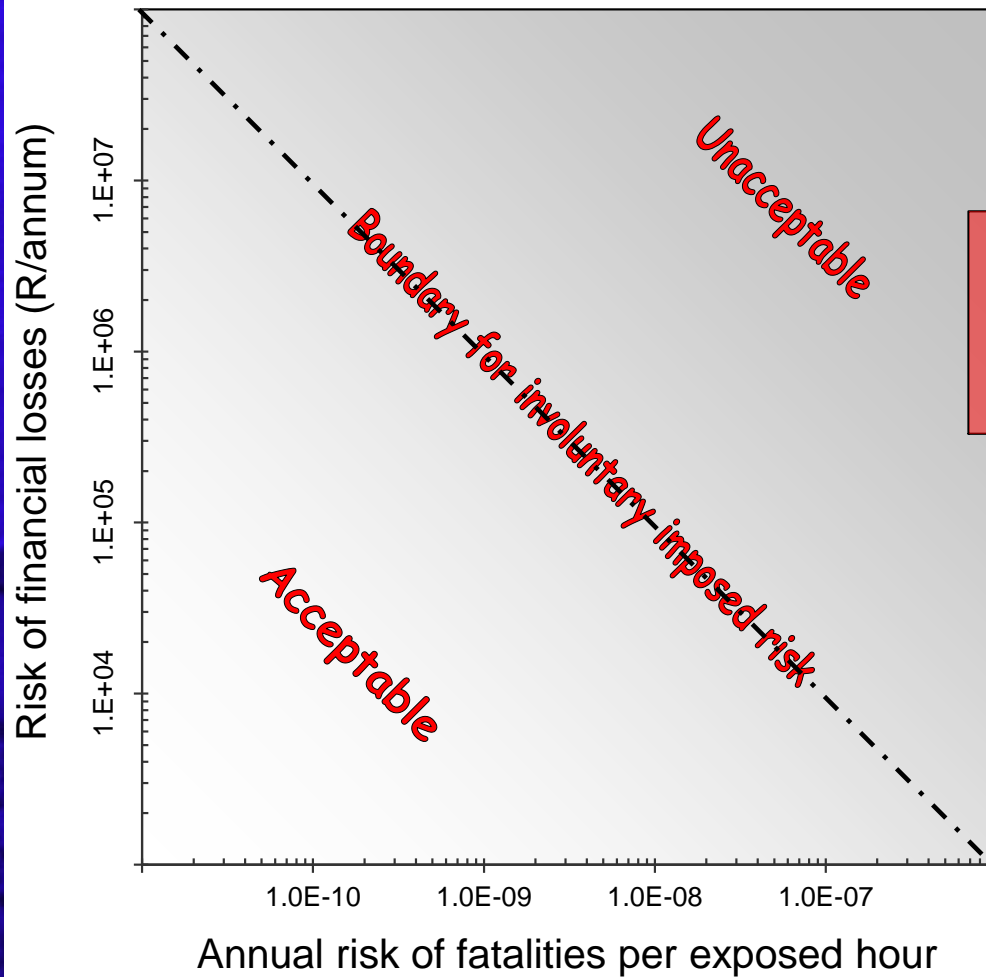
Risk level

Normal operation

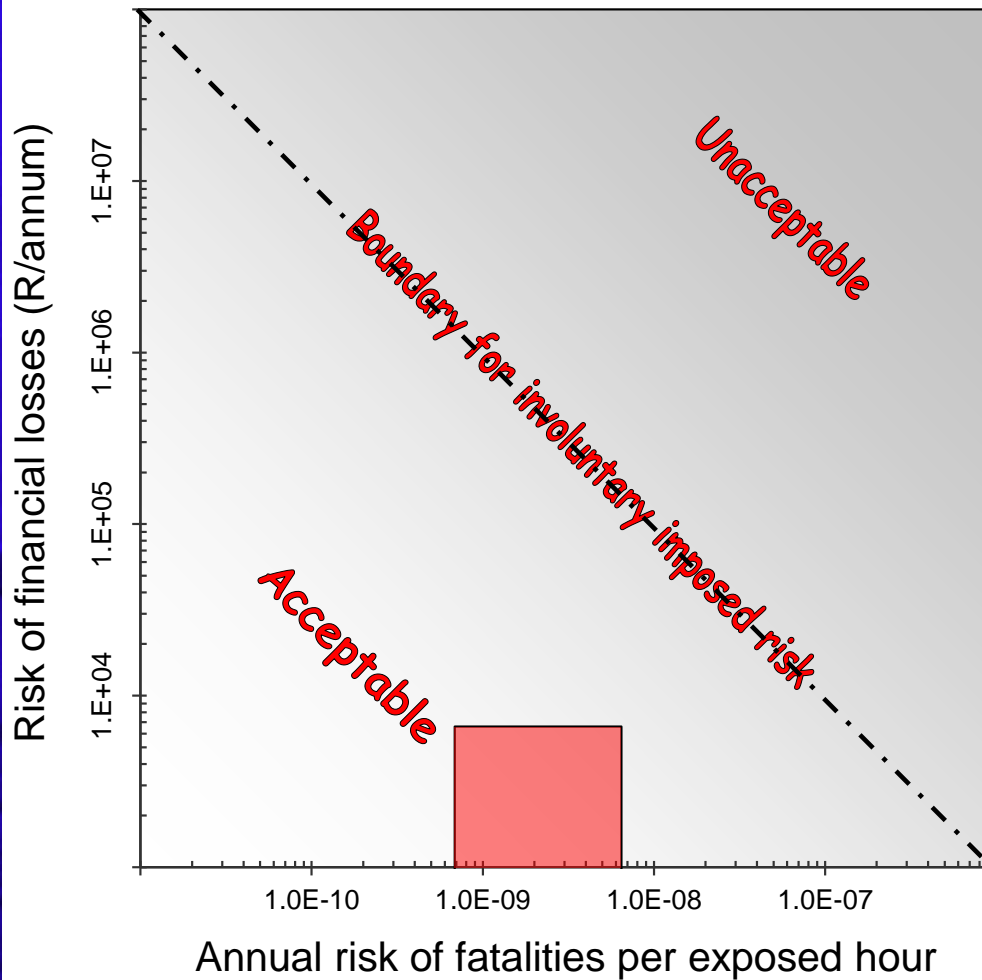
Rehabilitated

Risk level

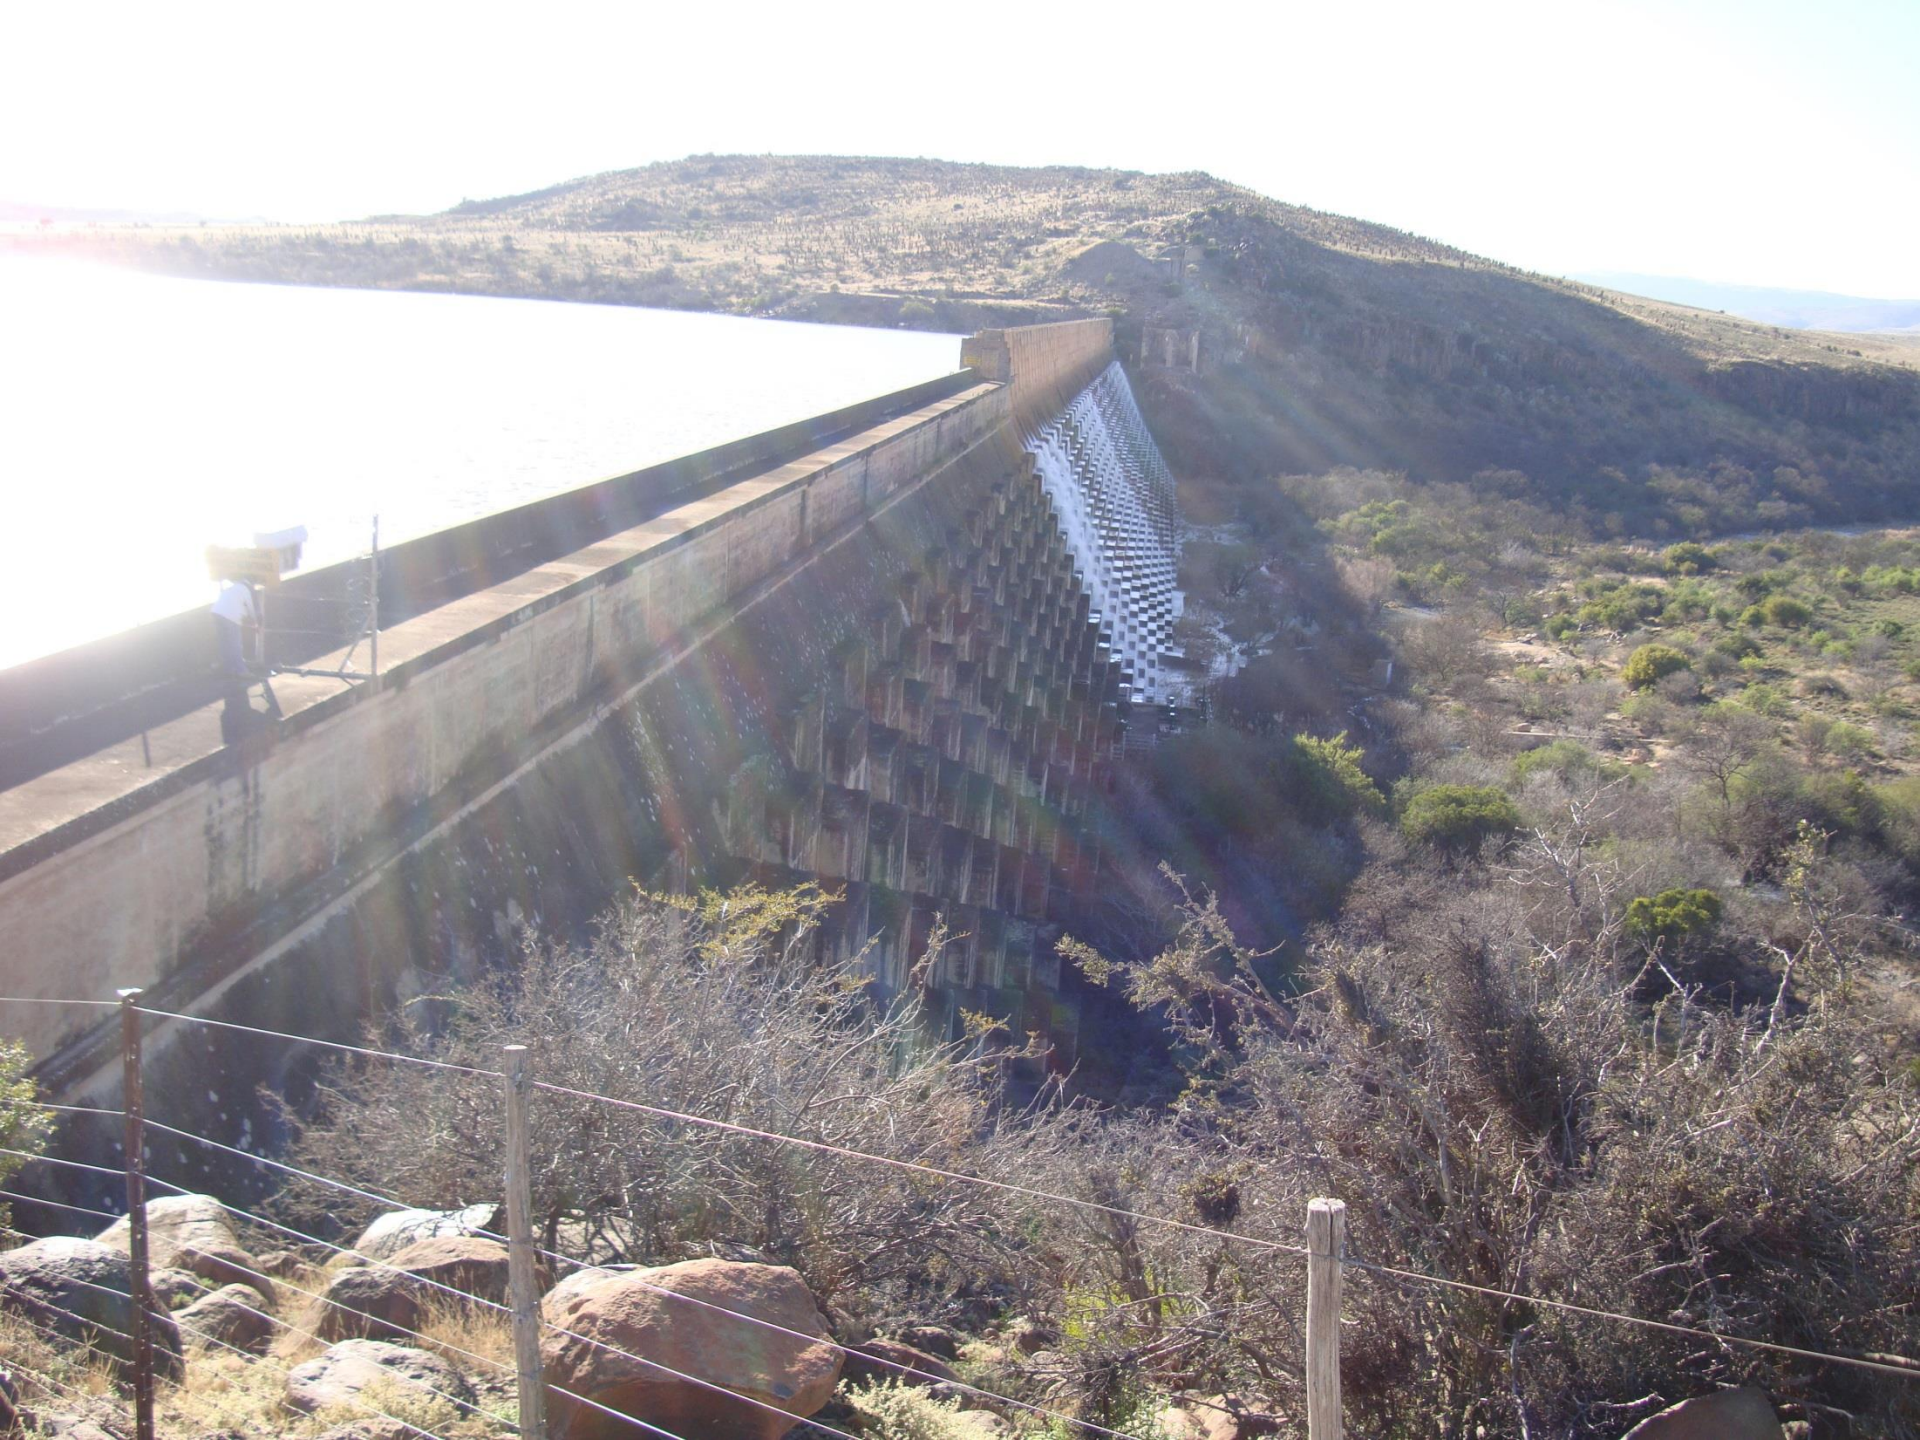
Lake Arthur Dam

- Concrete gravity: 33.7 m high
- Completed in 1924
- 1939: 66 roller (sluice) gates on spillway crest - lifted by manually operated winch
- 1945: Gates extended by 0.9 m
- 2003: Gates removed

- Fatal flaw in design - opening speed
- Lack of:
 - On site personnel
 - Redundancy
 - Maintenance

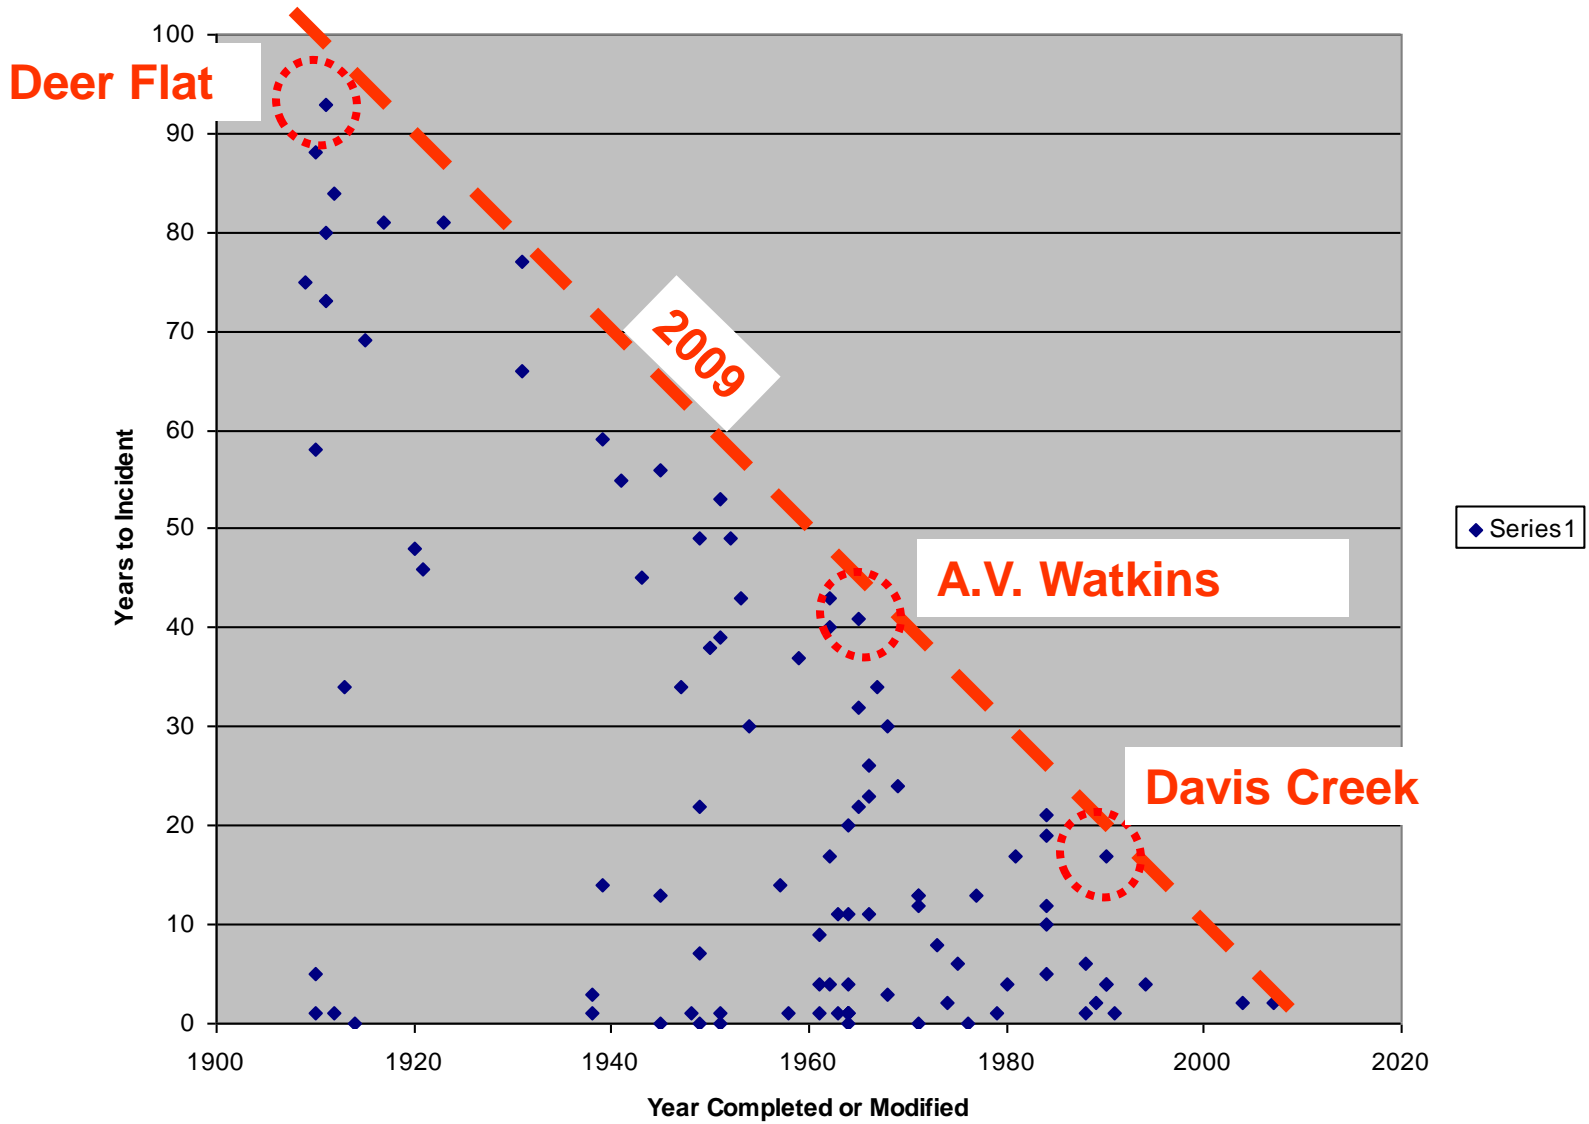
Internal Erosion Incident History

ONLY EMBANKMENT FAILURES

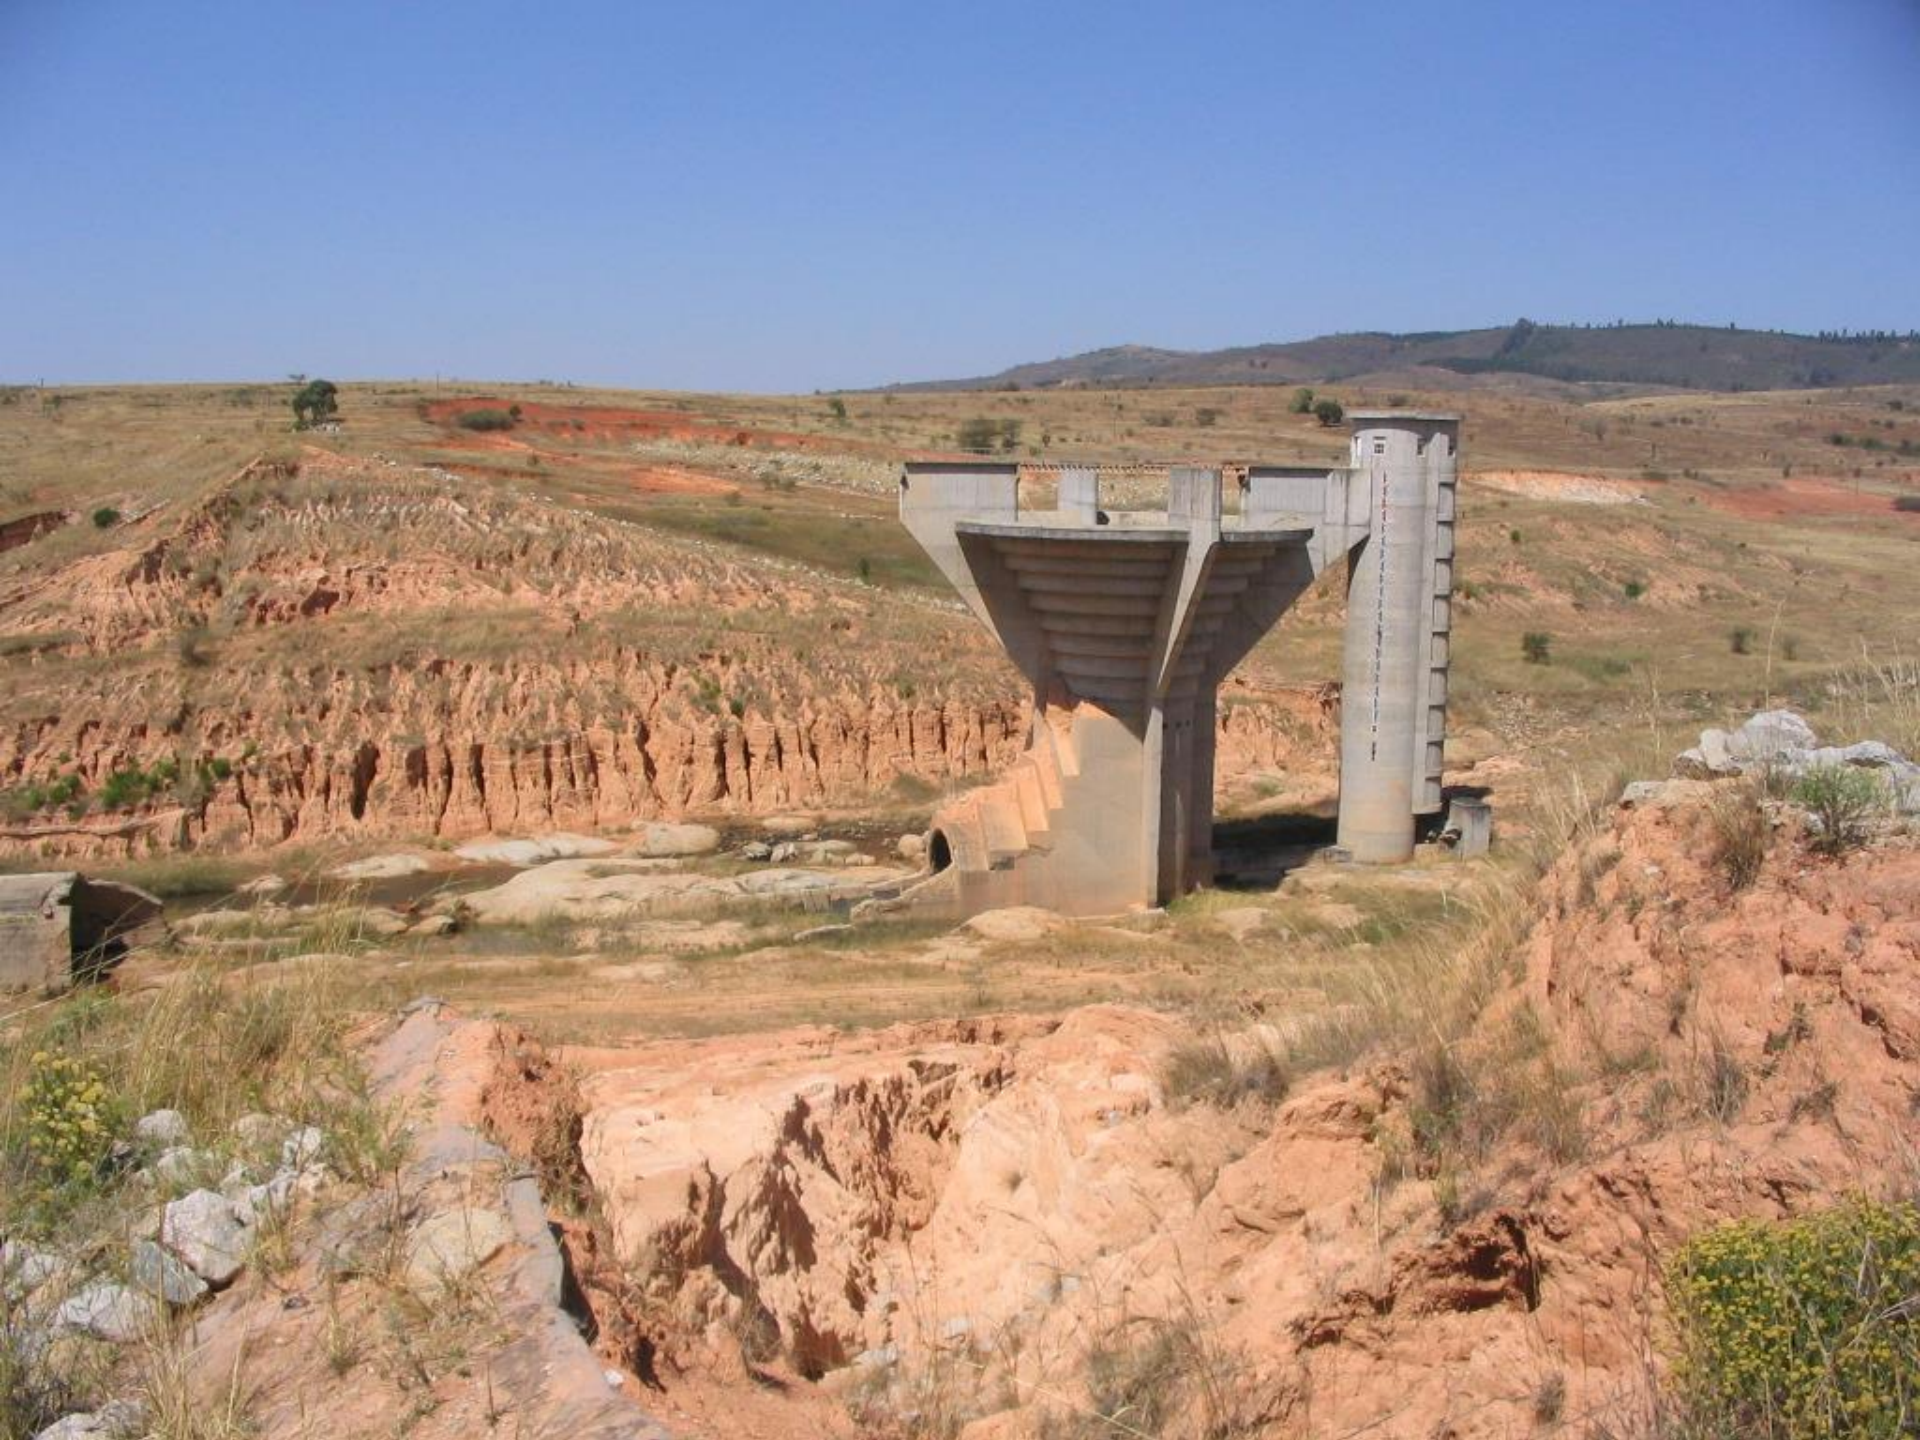
WALLY HOLMES DAM

Failure due to internal erosion caused by poor compaction.

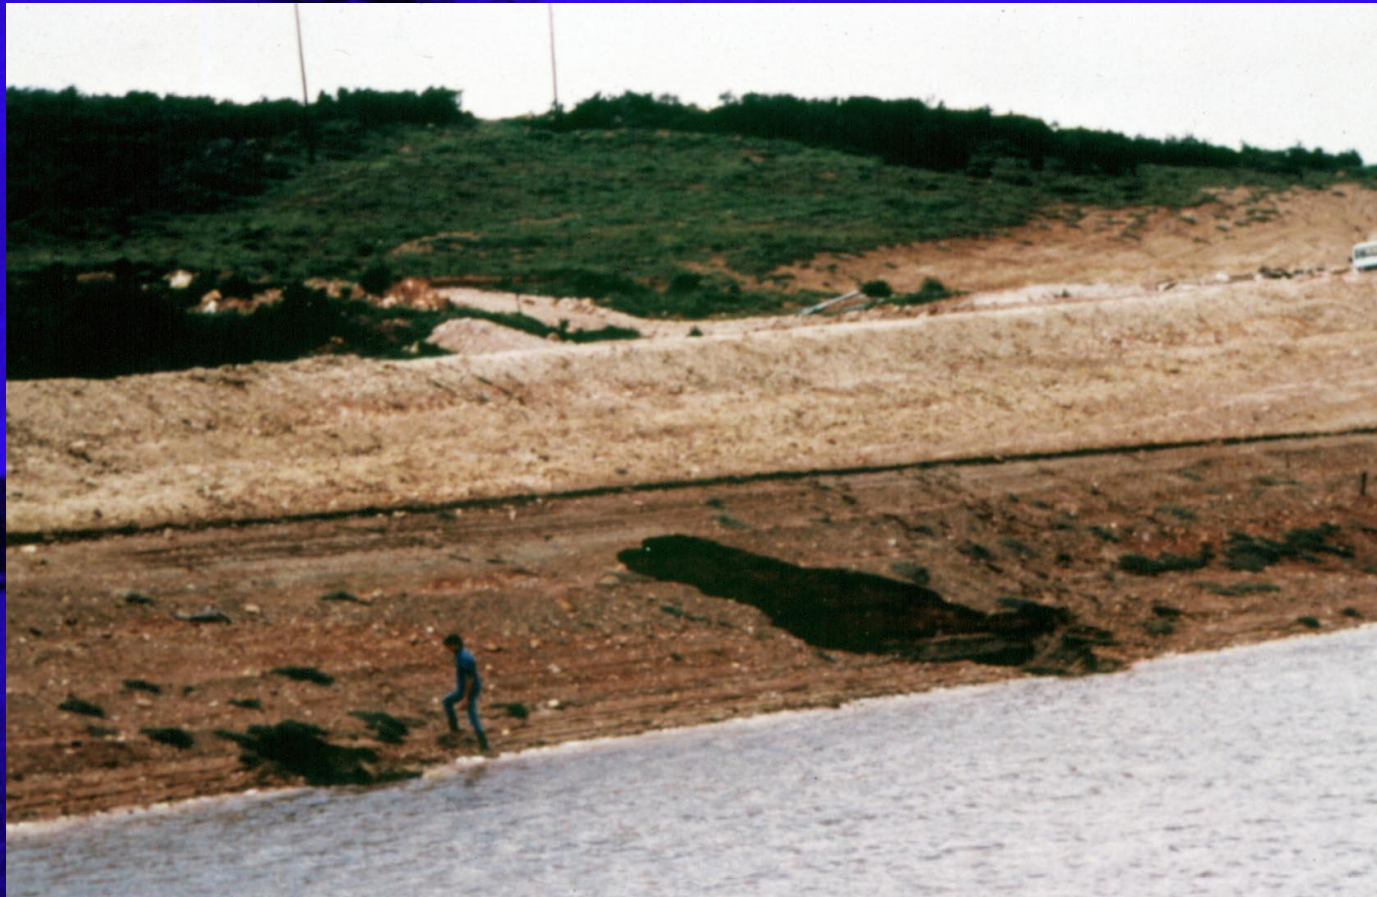
WALLY HOLMES DAM

Note size of "pipe or tunnel" compared to height of the interested observer

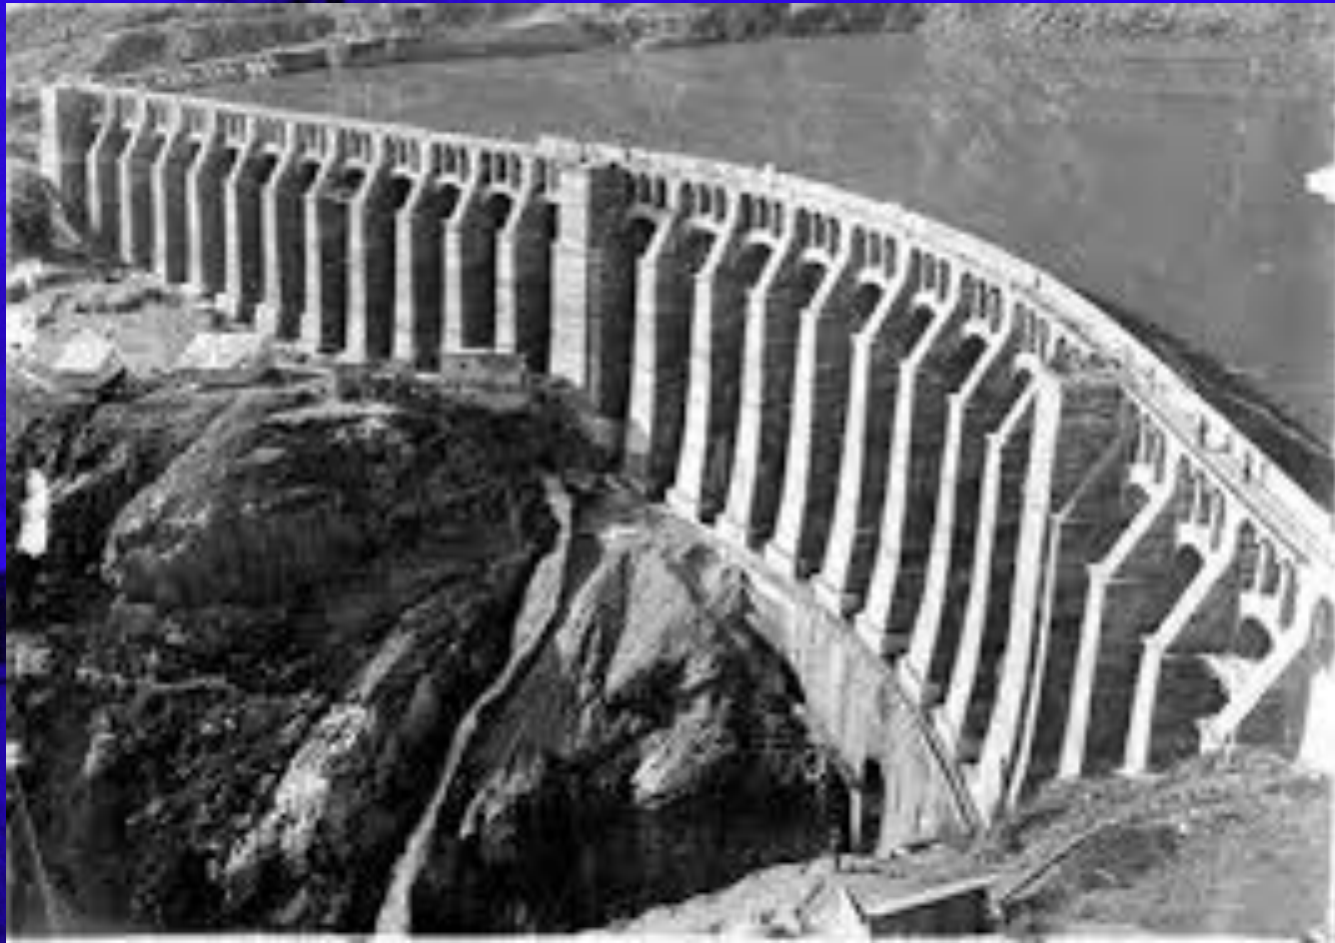
Gleno Dam, Italy

- 50 m high multiple concrete arch dam 213 m long
- Masonry gravity plug built in deep central valley gorge (use lime mortar instead of cement mortar)
- Original concrete gravity
- Changed to multiple arch but not approved
- 1923:
 - Failure of one of the buttresses leading to multiple arch failure
 - 356 fatalities

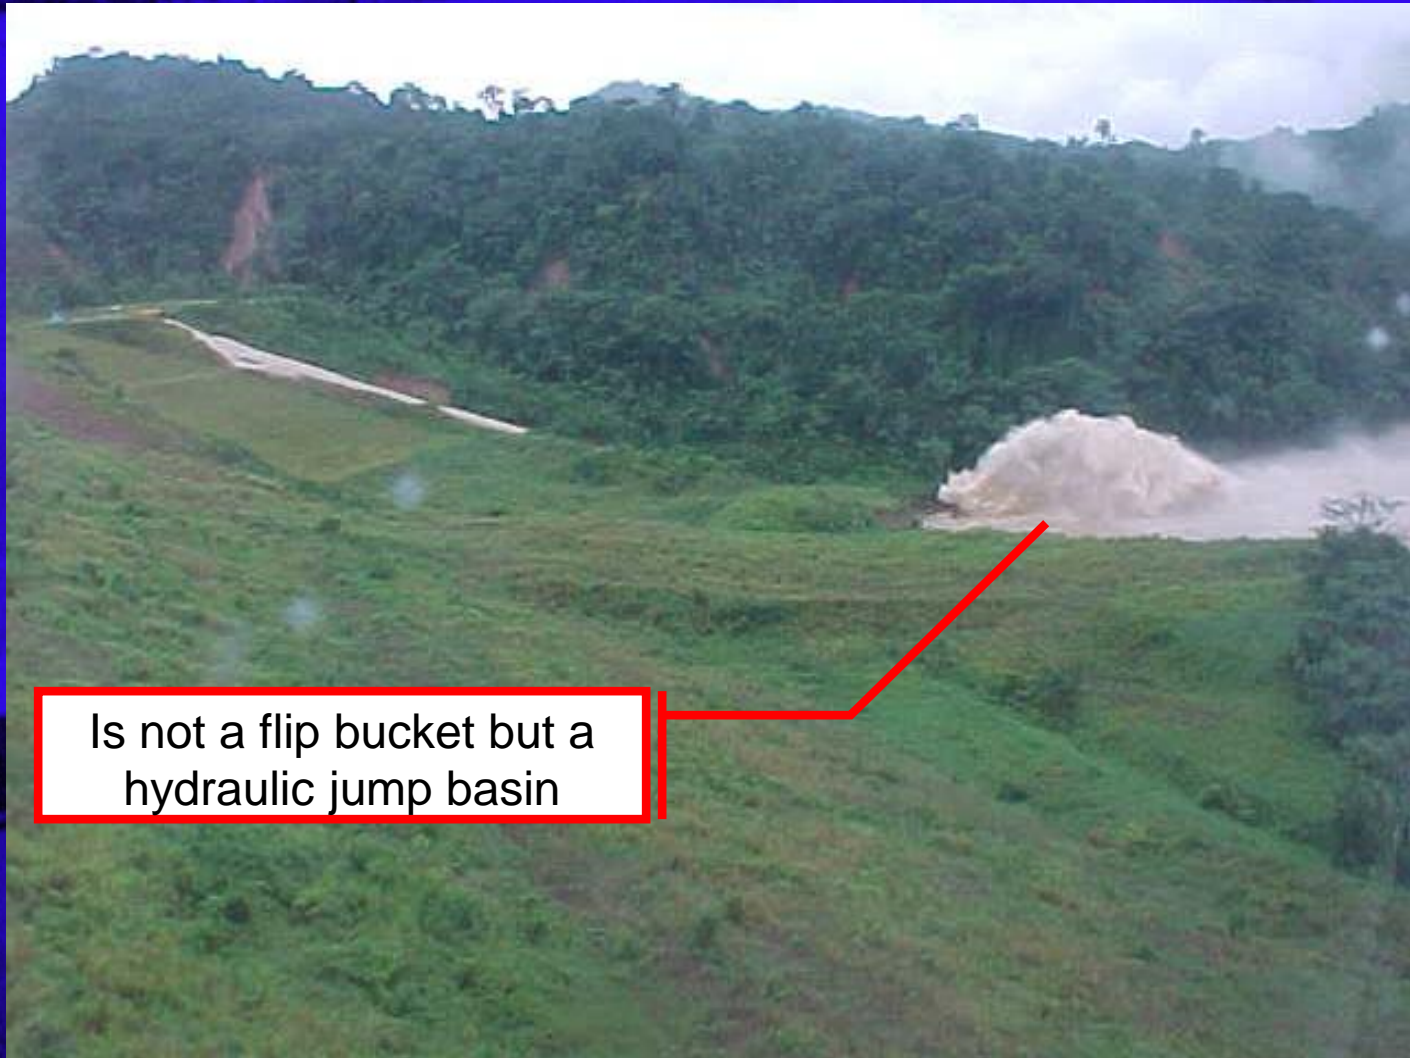
Is not a flip bucket but a hydraulic jump basin

- Built 1975 to 1980
- No proper hydrologic studies - based on similar basin
- Spillway system
 - Original uncontrolled ogee with downstream chute
 - Tunnel spillway added after chute wall overtopping during construction
- Failure in 1999

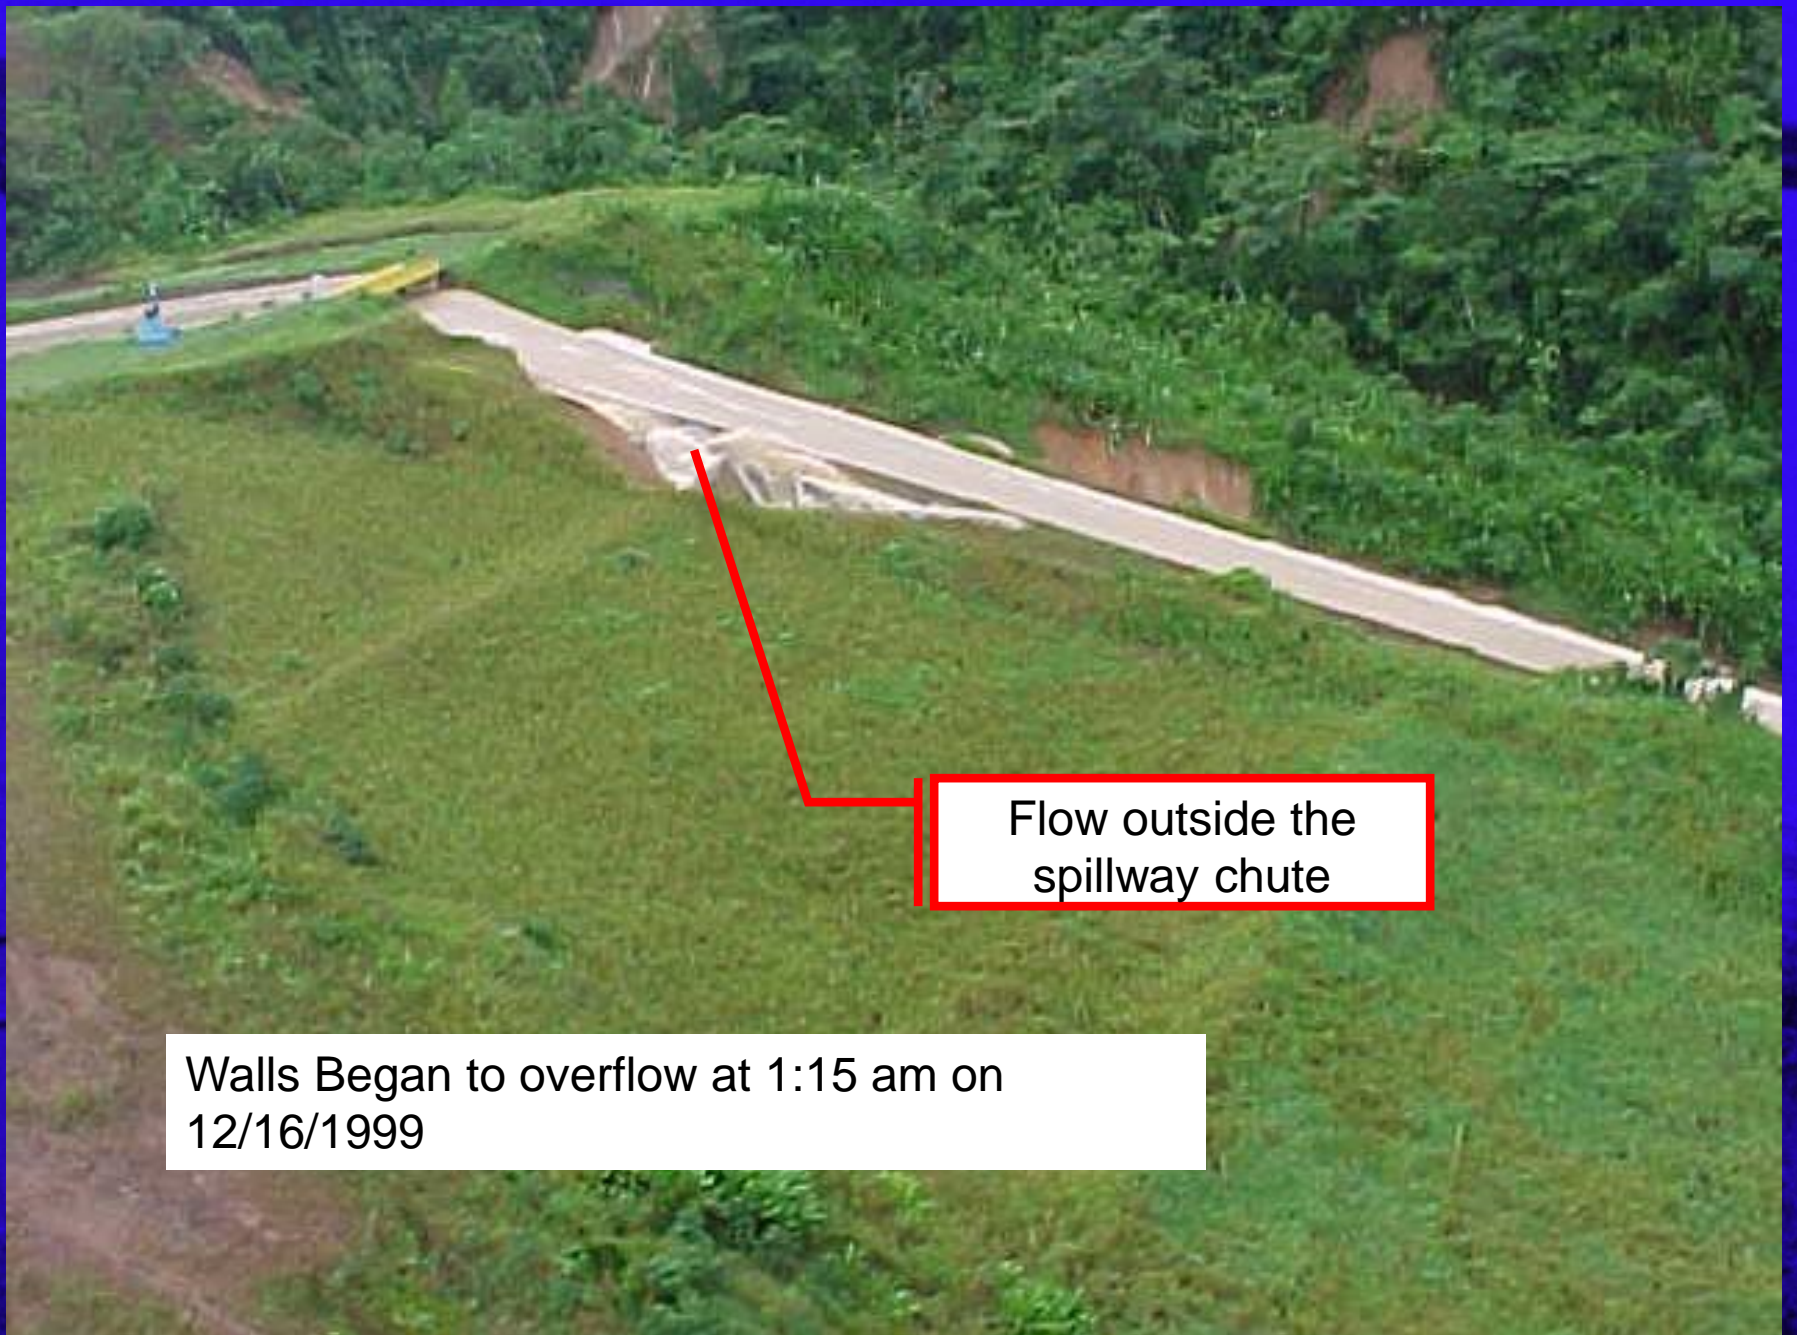
Flow outside the
spillway chute

Walls Began to overflow at 1:15 am on
12/16/1999
