Dam Safety in a Water Resource Environment

Dam Safety Regulation in South Africa: 32 years down the line

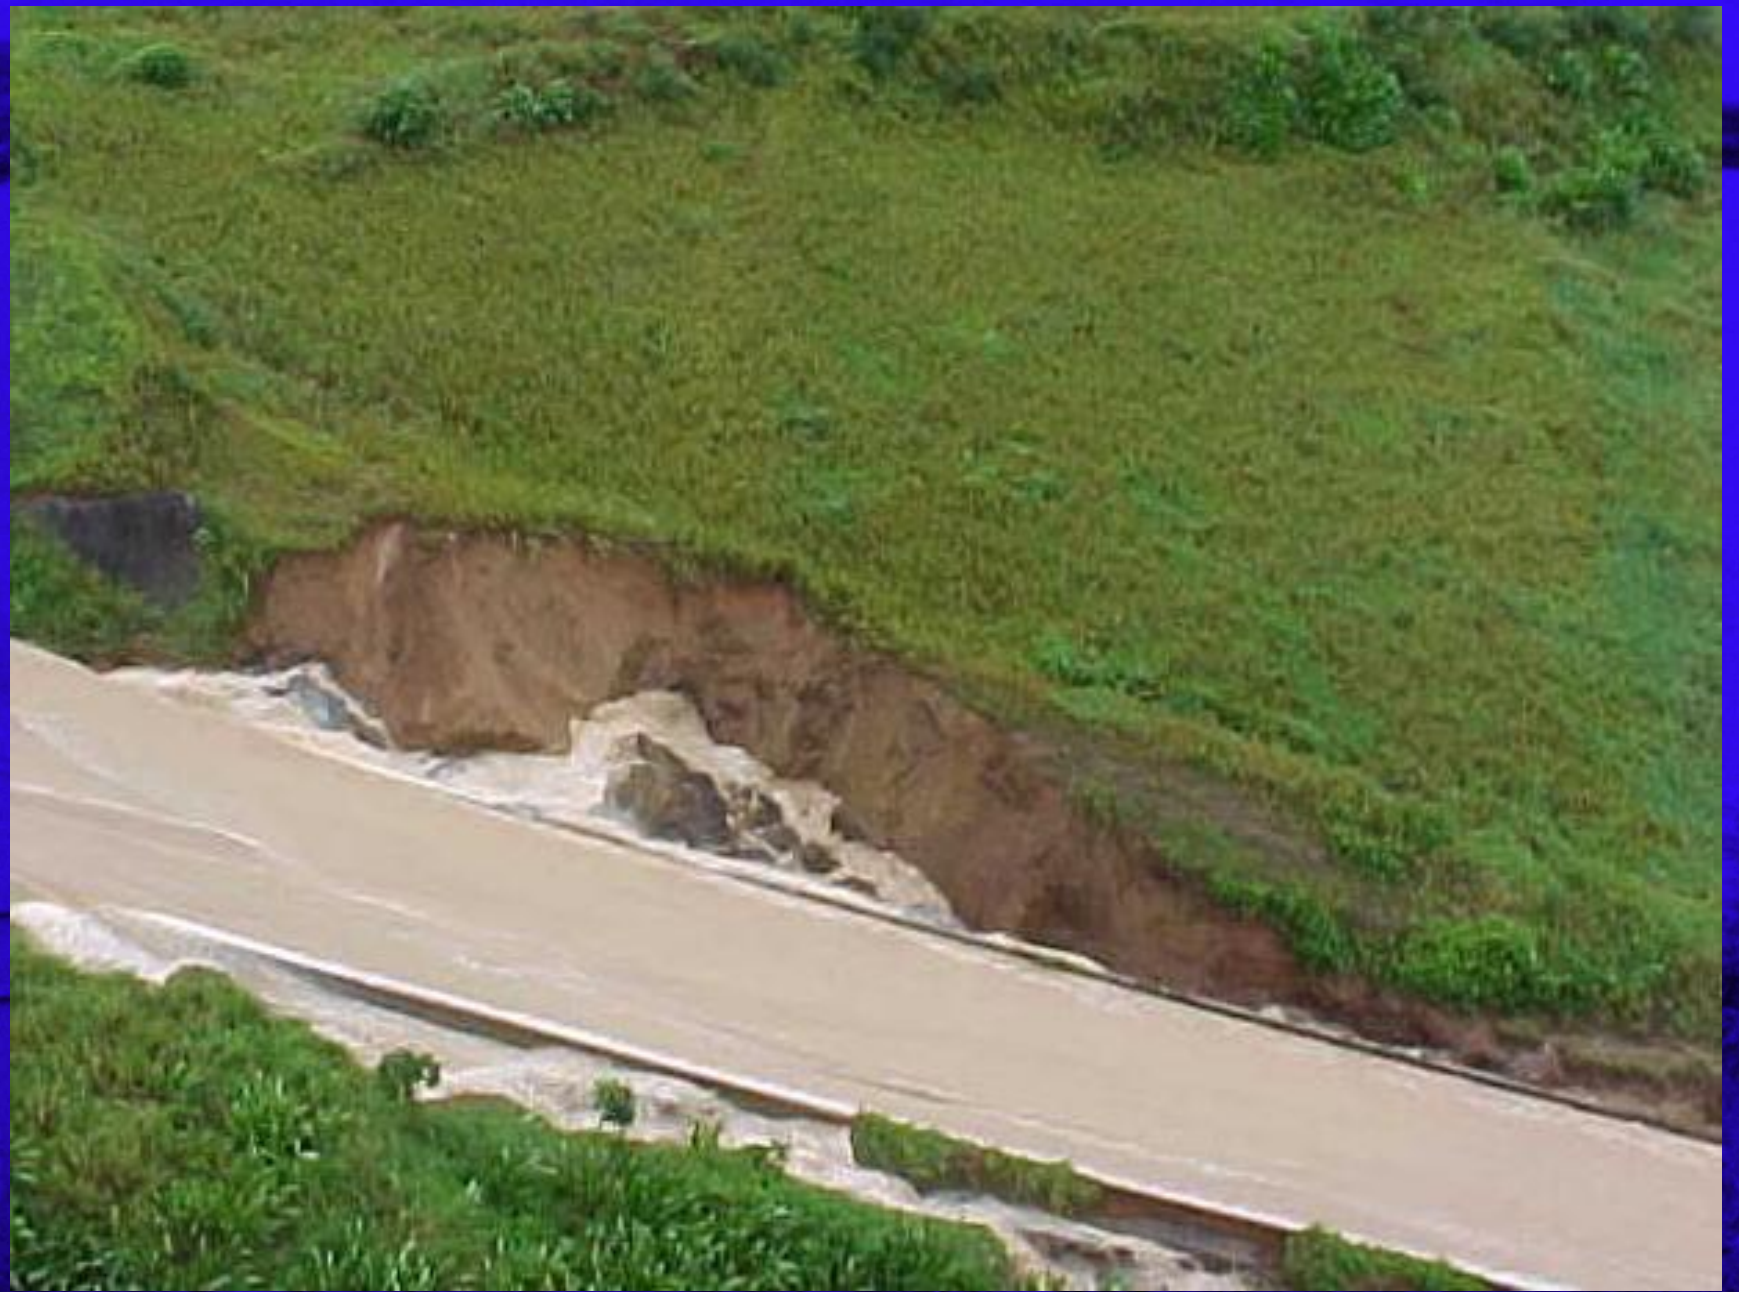
Water level rose again – erosion had undercut basin, chute and spillway weir at 4:00 pm on 12/16/1999

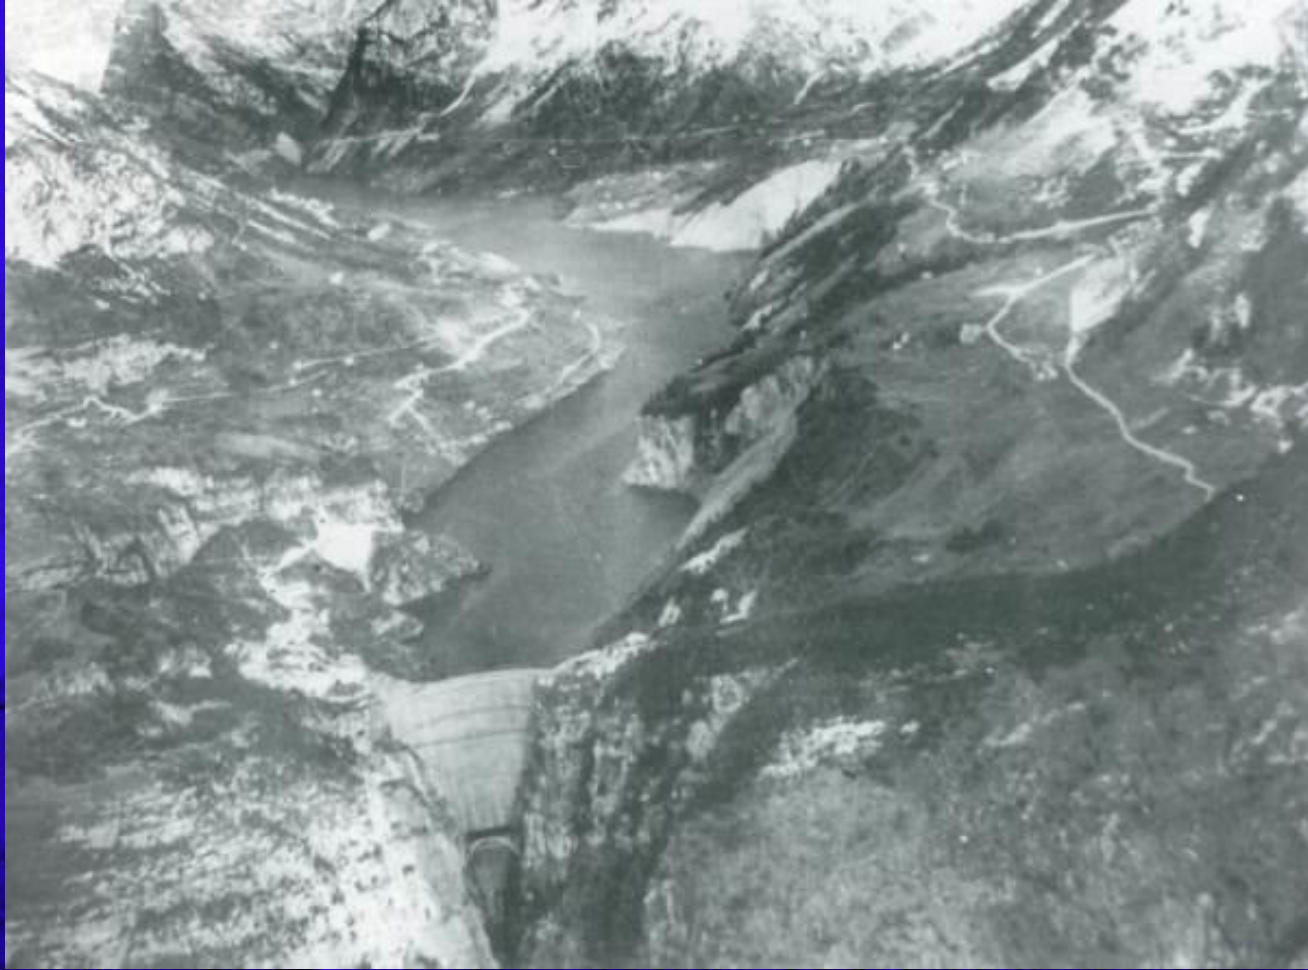
Vajont Dam, Italy

- 265 m high concrete arch dam
- Completed in 1960
- Left side reservoir foundation = steep slopes in bedded limestone with clay interbeds
- 1 month after completion & after heavy rain = first landslide = 700 000 m³ & 2 m wave
- Exploratory adits, piezometers & level of reservoir adjusted to limit slide movement
- 1963
 - Massive slide of 267 million m³
 - 100 m high over dam wall
 - 2 600 fatalities
 - Arch survived
